AHERA THREE YEAR REINSPECTION

**Kern Seventh Day Adventist
Elementary School
Shafter, CA**

May 14, 2014

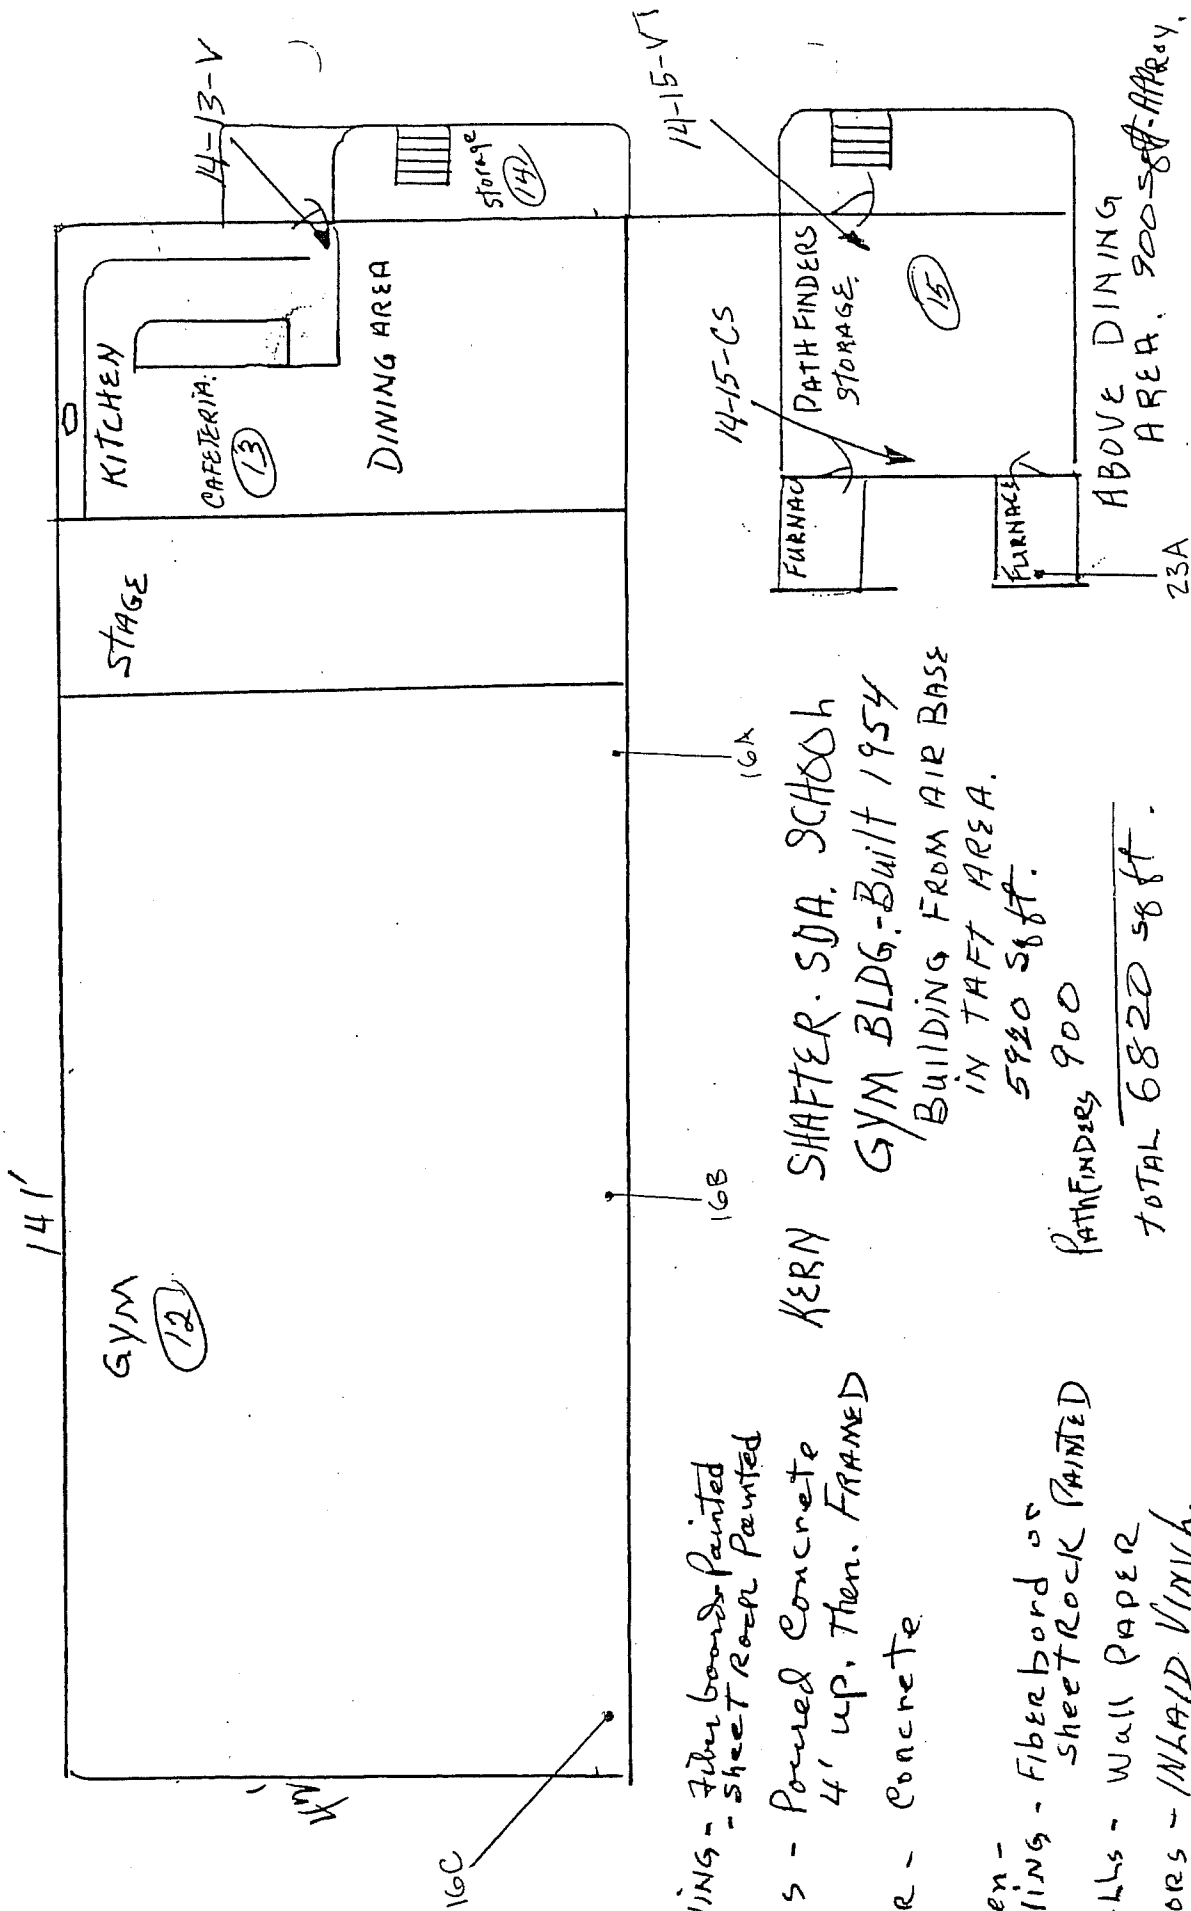
GYM. CEILING - Fiber board Painted
 - Sheet Rock Painted
 Walls - Poured Concrete
 4' up. Then. FRAMED
 Floor - Concrete
 Kitchen -
 ceiling - Fiber board or
 sheet rock Painted
 walls - wall paper
 Floors - INLAID Vinyl.
 ALSO ON WORK TABLE.

KERN SHAFER SDA. SCHAUGH
 GYM BLDG. - Built 1954
 BUILDING FROM AIR BASE
 IN TAFT AREA.
 5920 sq ft.
 PATHFINDERS 900
 TOTAL 6820 sq ft.
