**ASBESTOS HAZARD EMERGENCY RESPONSE ACT (AHERA)
GENERAL DATA
(FORM A)**

Inspection Date: May 1, 2014

Central California Conference of 7th Day Adventists

Mariposa SDA Elementary

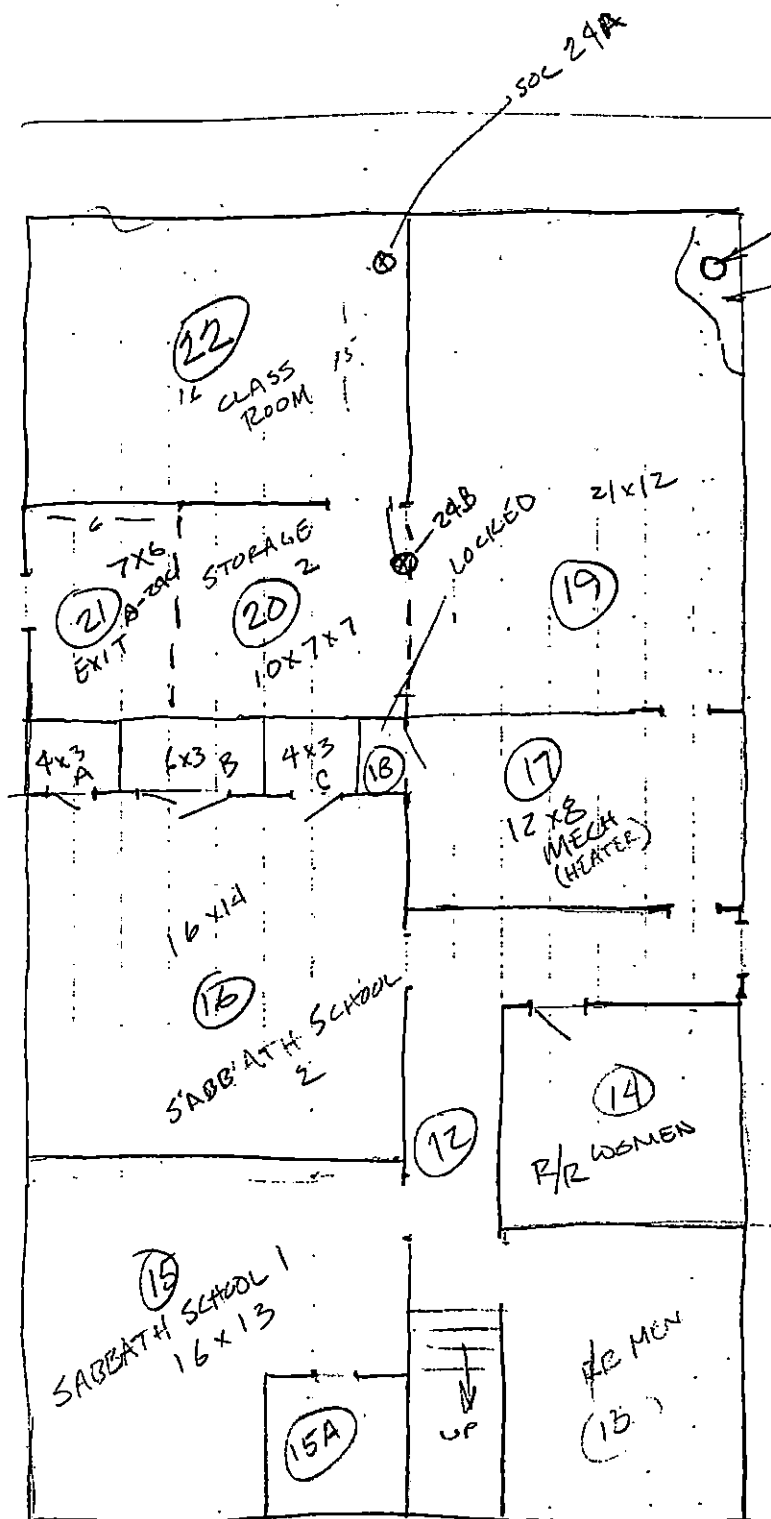
Building 4
Church, Basement

TRANSITE
FLUE
PLASTER AROUND FLUE
1/2 ON WALL
