ASBESTOS HAZARD EMERGENCY RESPONSE ACT (AHERA)
GENERAL DATA (FORM A)

LOCAL EDUCATION AGENCY	County
Central California Conference	Fresno
SCHOOL NAME	**Phone number**
Dinuba Junior Academy	(209)591-0194

RECORD OF FRIABLE AND NONFRIABLE ACBM
(FORM B)

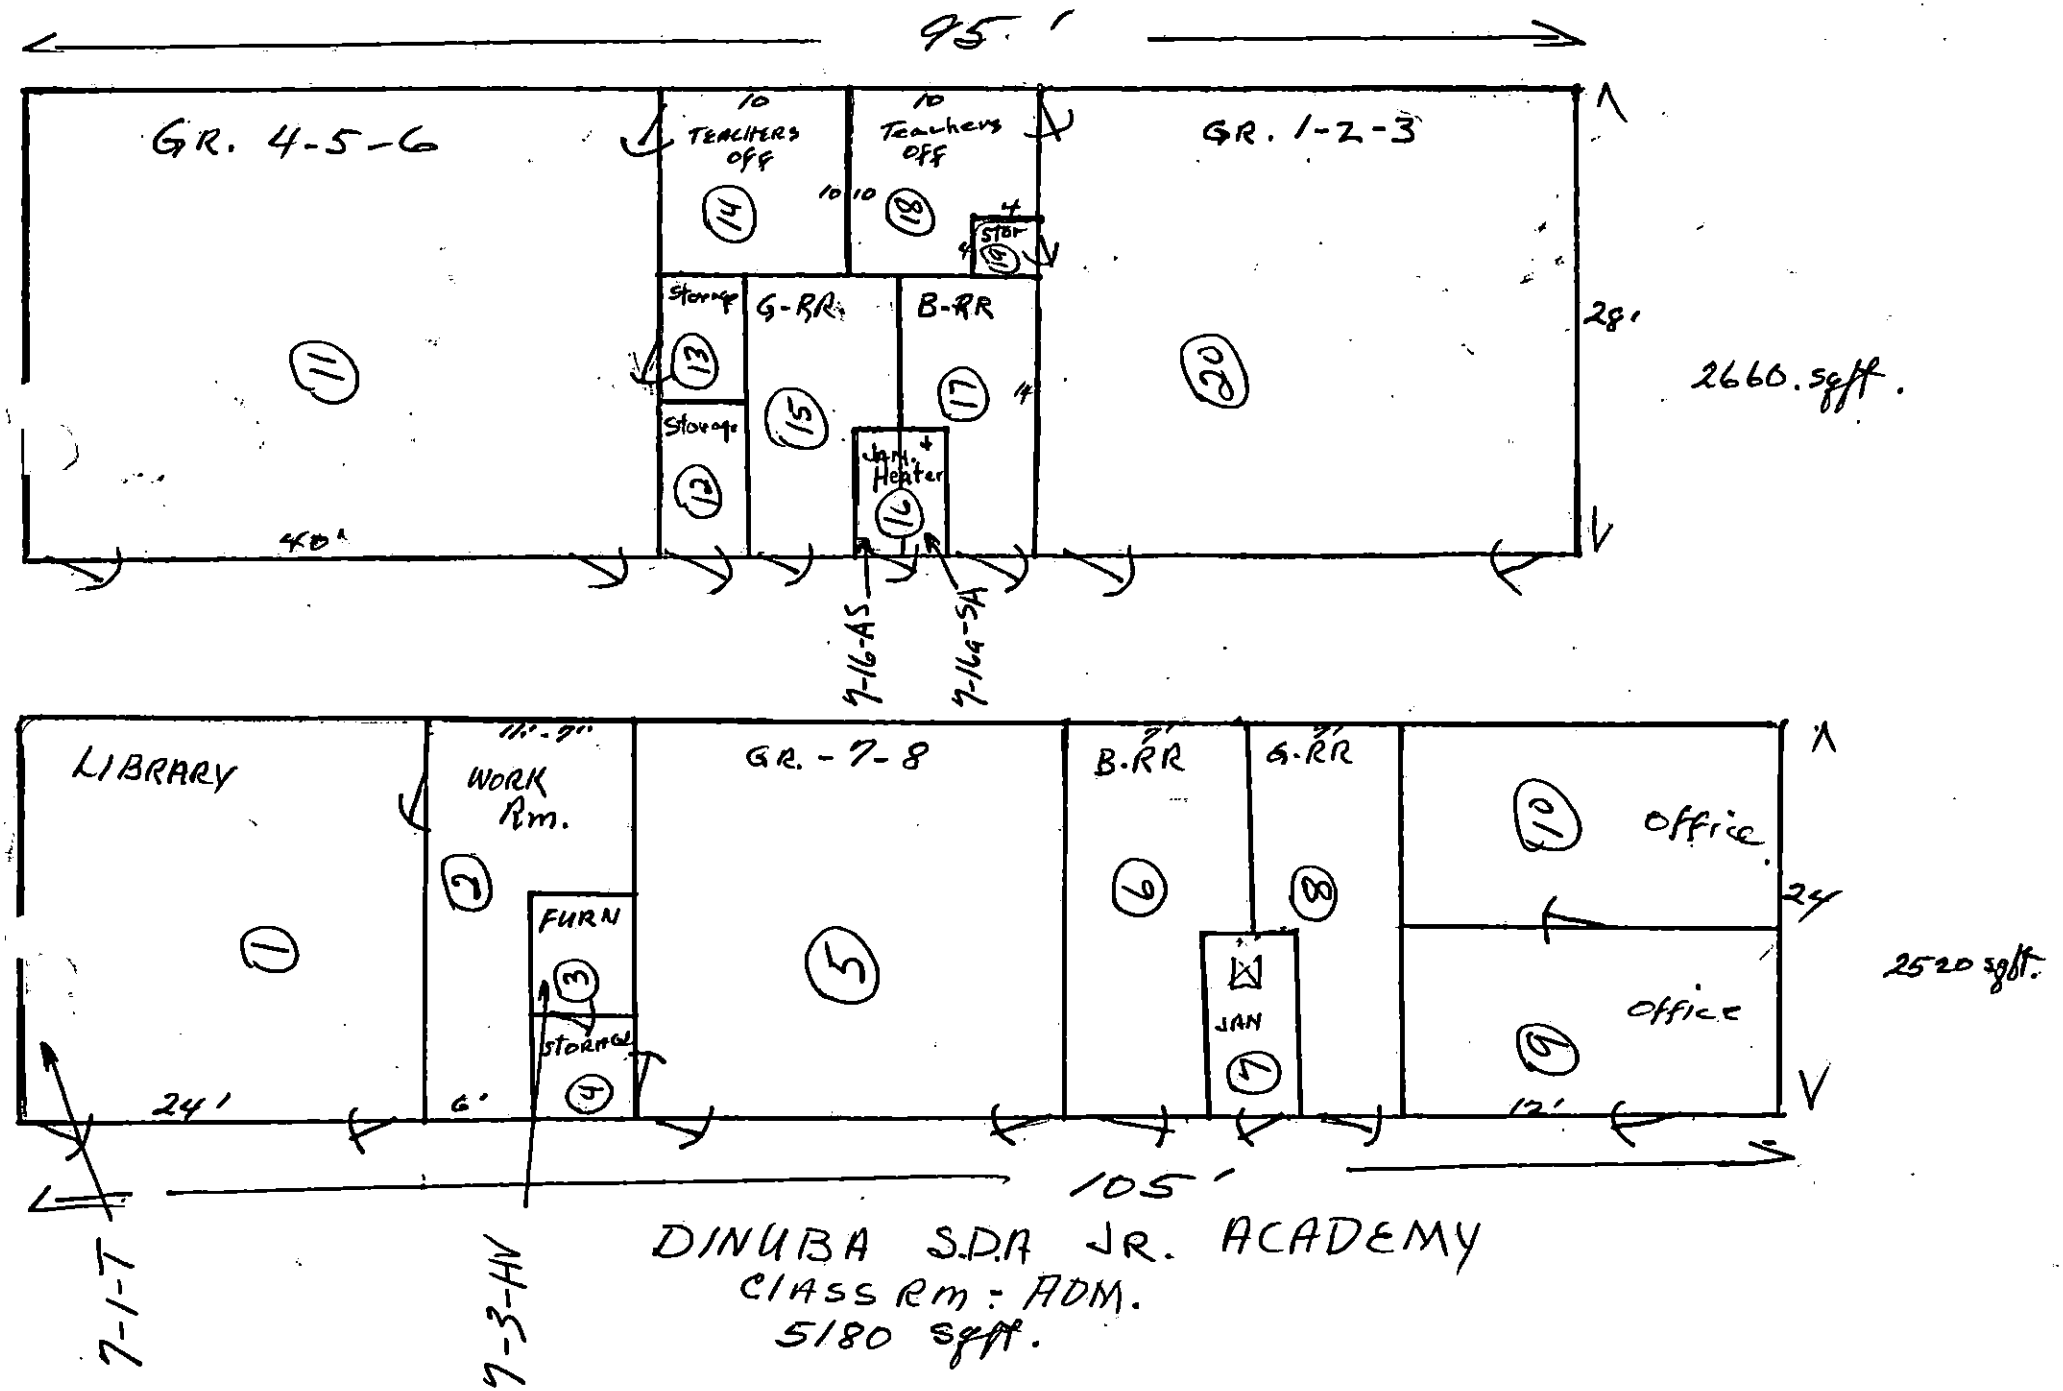
95'
GR. 4-5-6
10
TEACHERS OFF
14
10
10
Teachers OFF
18
10
4
STOR
19
GR. 1-2-3
Storage
13
G-RR
B-RR
11
15
17
4
20
28'
2660. sqft.
Storage
12
Jan. Heater
16
40'
7-16-AS
7-16-SA
LIBRARY
1
11'-9"
WORK Rm.
2
FURN
3
STORAGE
4
GR. - 7-8
5
B.RR
6
G.RR
8
JAN
7
10
Office
24'
9
Office
2520 sqft.
24'
6'
12'
105'
7-1-T
7-3-HV
DINUBA S.D.A JR. ACADEMY
CLASS RM: ADM.
5180 sqft.

Description: acoustical sprayed ceiling - also in grades 4, 5+6, & 1st/2nd + 3rd.

Percent Damage: 2 %, ✓ Localized, ____ Distributed

Type of Damage: ____ Deterioration, ✓ Water, ____ Physical

Overall Rating: ____ Good, ✓ Fair, ____ Poor

The material on the ceiling in the janitors room and in grades 1,2,3 and grades 4,5,6 is in fair condition. We recommend you encapsulate the material with ABS-100 sealant or the equivalent or with a latex paint. Removal is an option you might consider which would cost from $8000.00 to $20000.00.

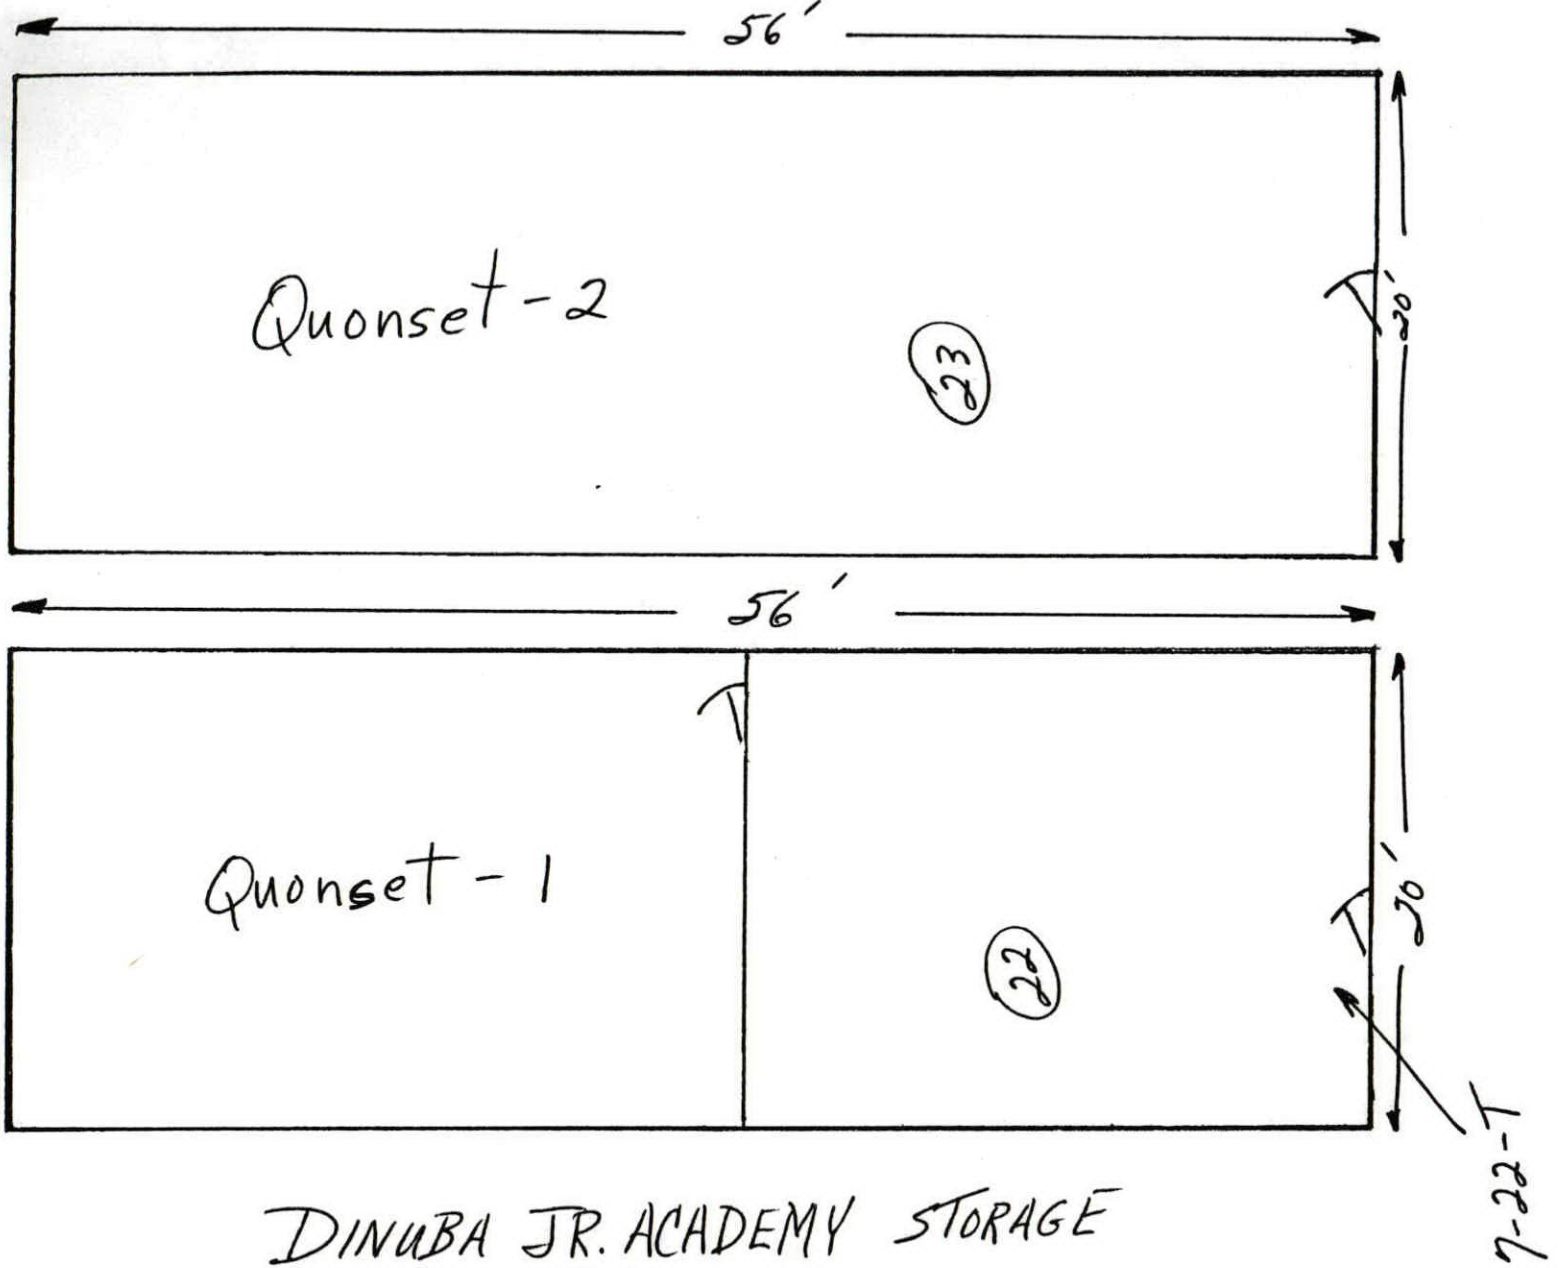
DINUBA JR. ACADEMY STORAGE

sq. footage - 2240

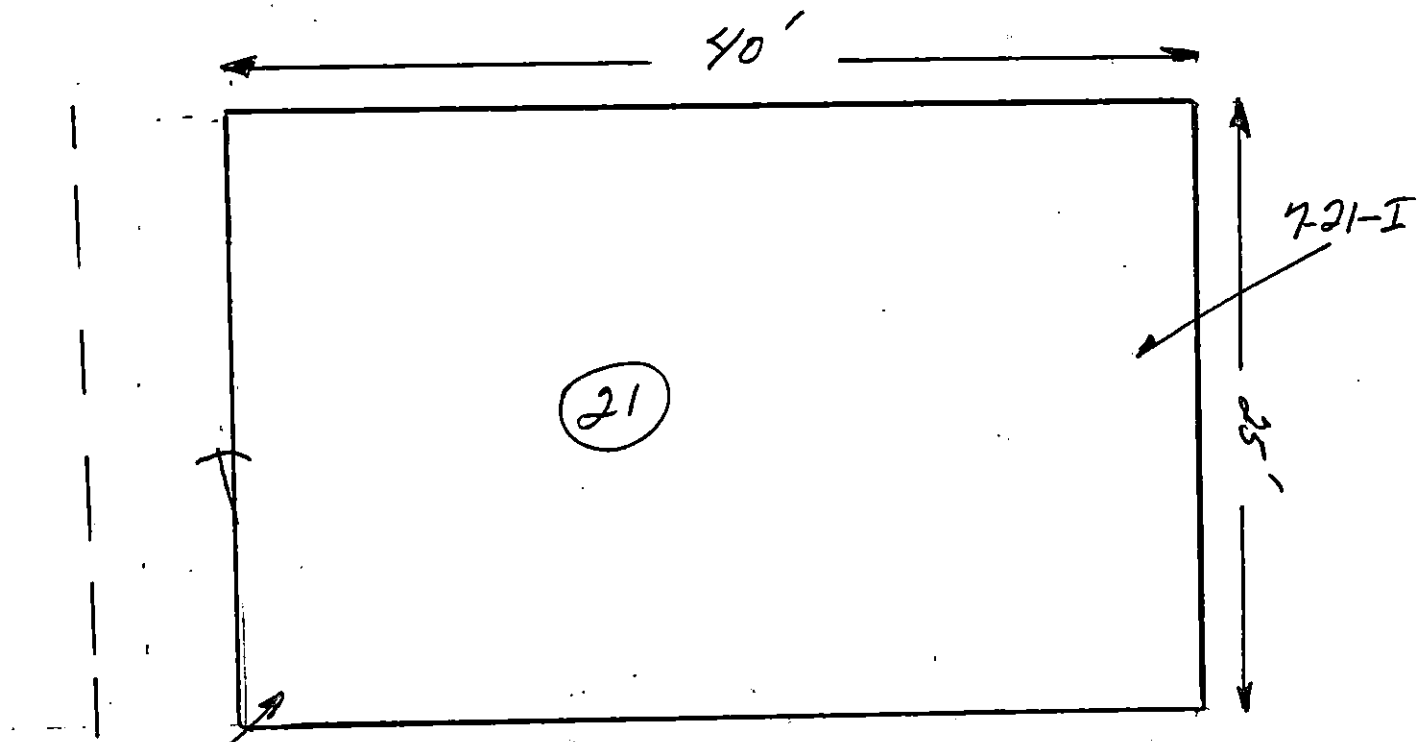
DINUBA JR. ACADEMY
9th & 10th grades
-1000 sq. ft.-

Functional Area No. 7-21-AS Location: 9th + 10th grades

Description: acoustical sprayed

Overall Rating: ✓ Good, ____ Fair, ____ Poor

The material on the ceiling in the 9th & 10th grades is in fair condition. We recommend you encapsulate the material with ABS-100 sealant or the equivalent or with a latex paint. Removal is an option you might consider which would cost from $5000.00 to $10000.00.
