ASBESTOS HAZARD EMERGENCY RESPONSE ACT (AHERA) 25A
GENERAL DATA (FORM A)

LOCAL EDUCATION AGENCY	County
CENTRAL CALIF.CONF.OF SDA	Calaveras
SCHOOL NAME	Phone number
MOTHER LODE JR. ACADEMY	209532-2855

The following Inspection Report was completed by Herbert and Gilbert Eslinger. Samples were taken randomly and in areas of convenience and inconspicuously according to Sec. 763.86 of the Federal Register.

RECORD OF FRIABLE AND NONFRIABLE ACBM
(FORM B)

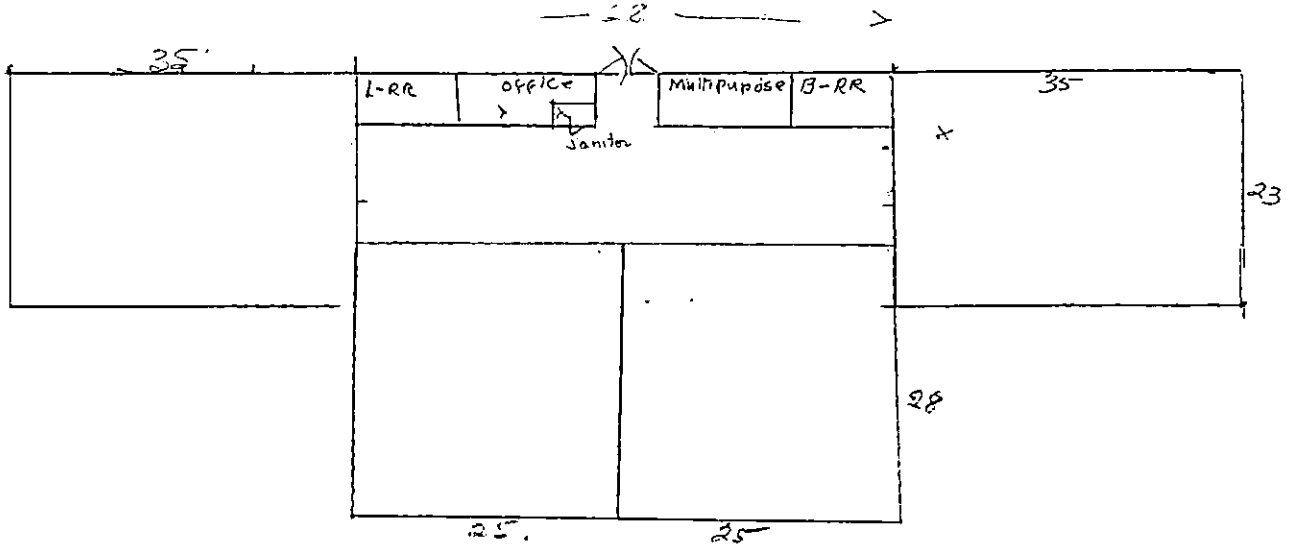
SONORA. Gym.

APPROX 3010 SQ ft.

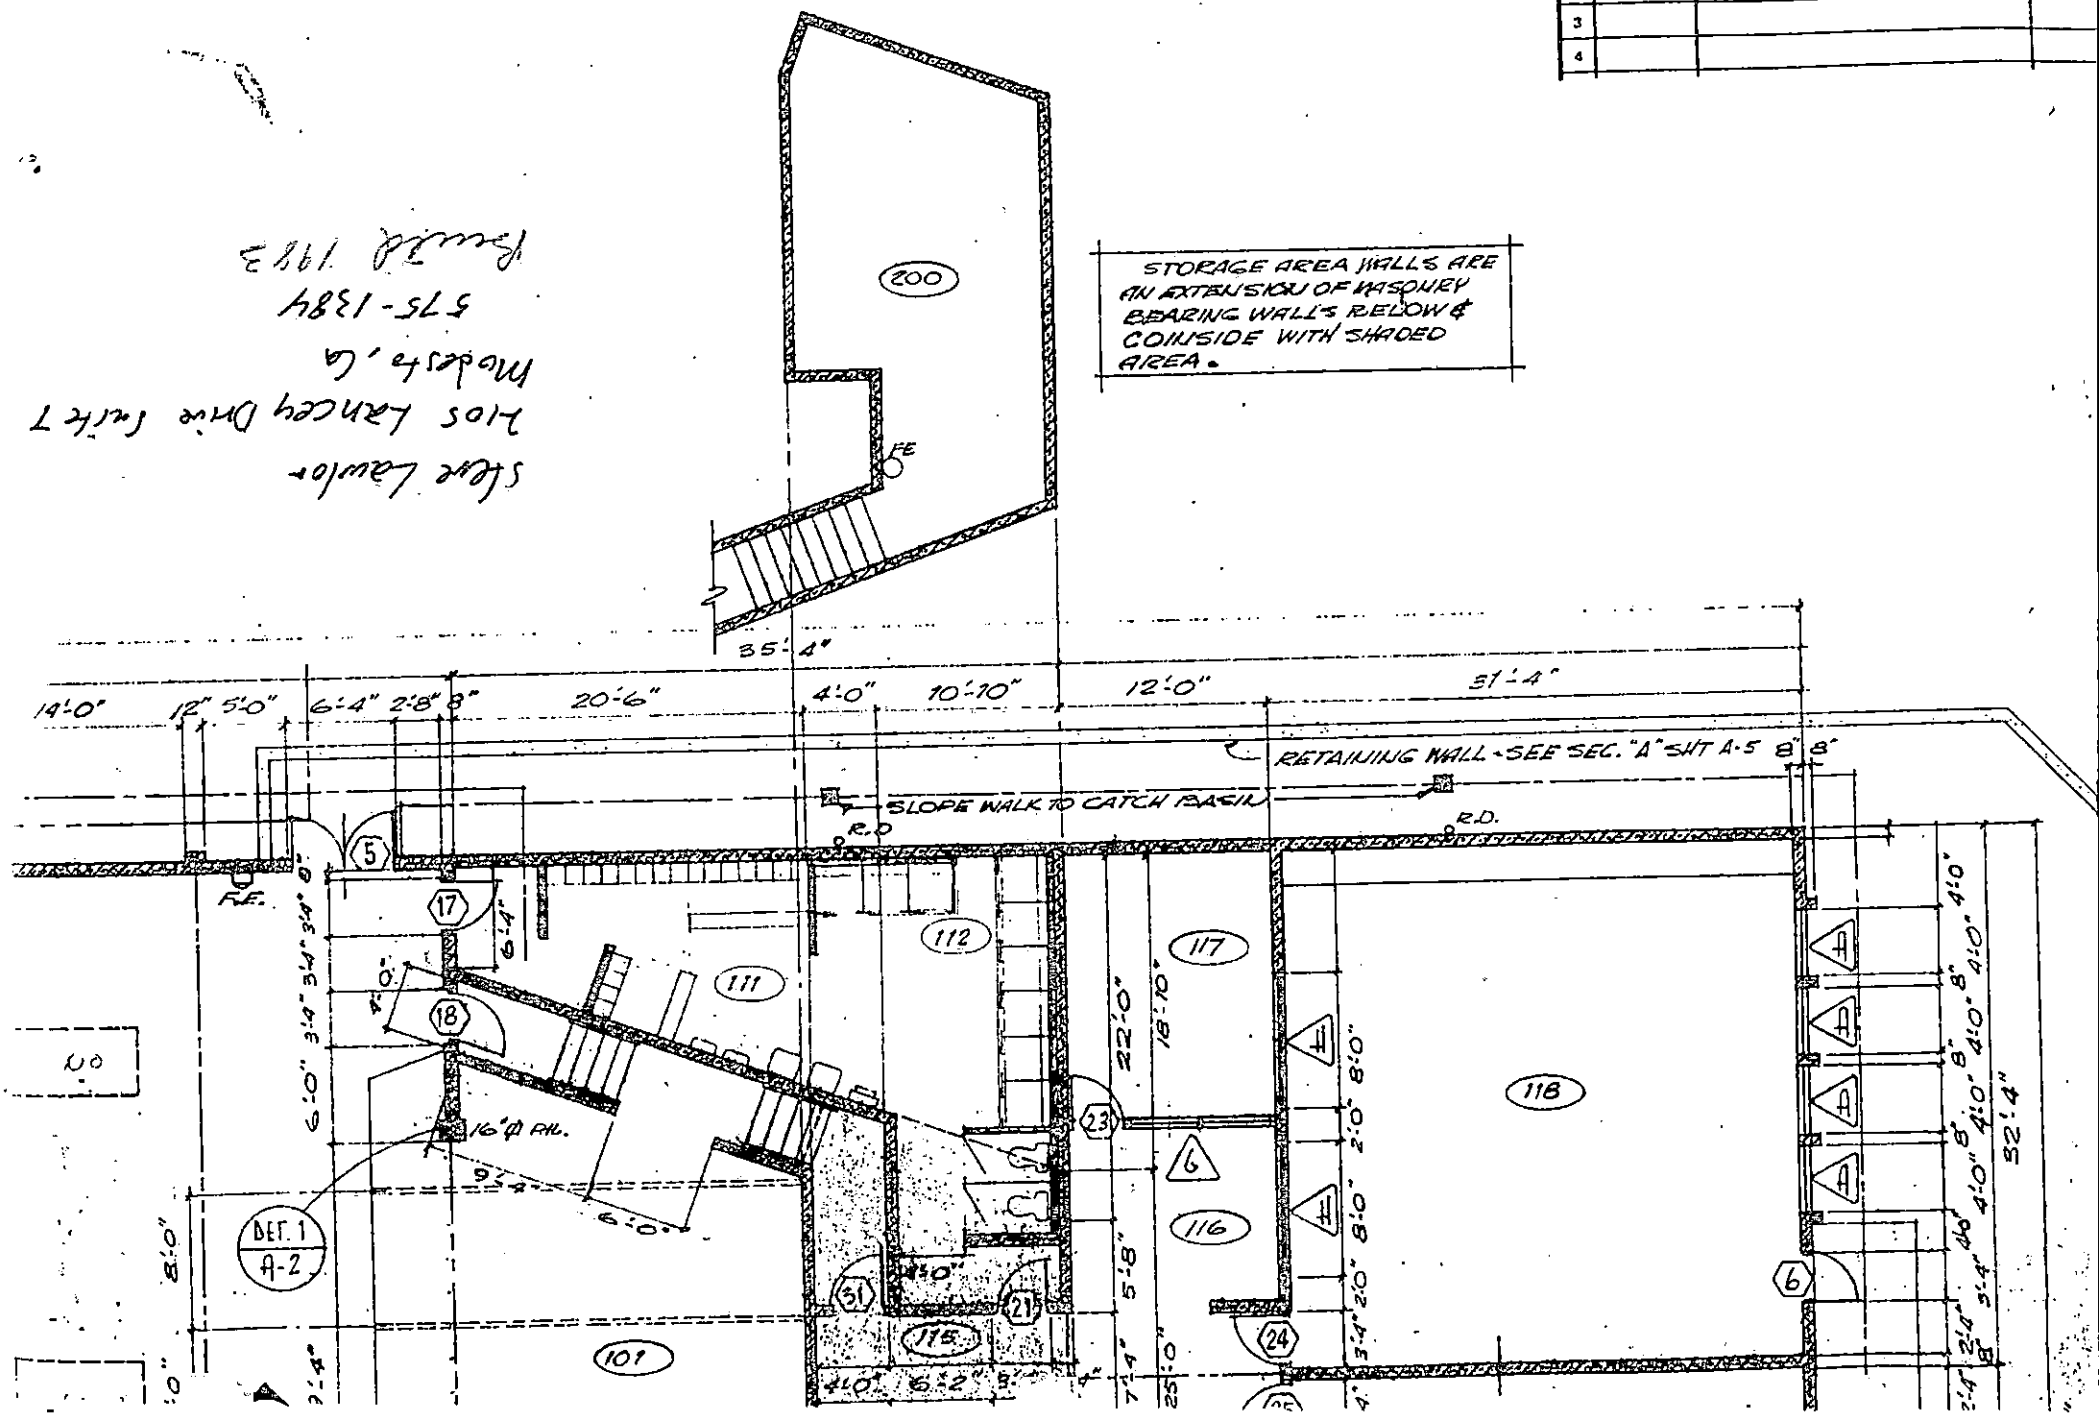
Sonora Gym Bldg.

Total sq. ft. 15,300

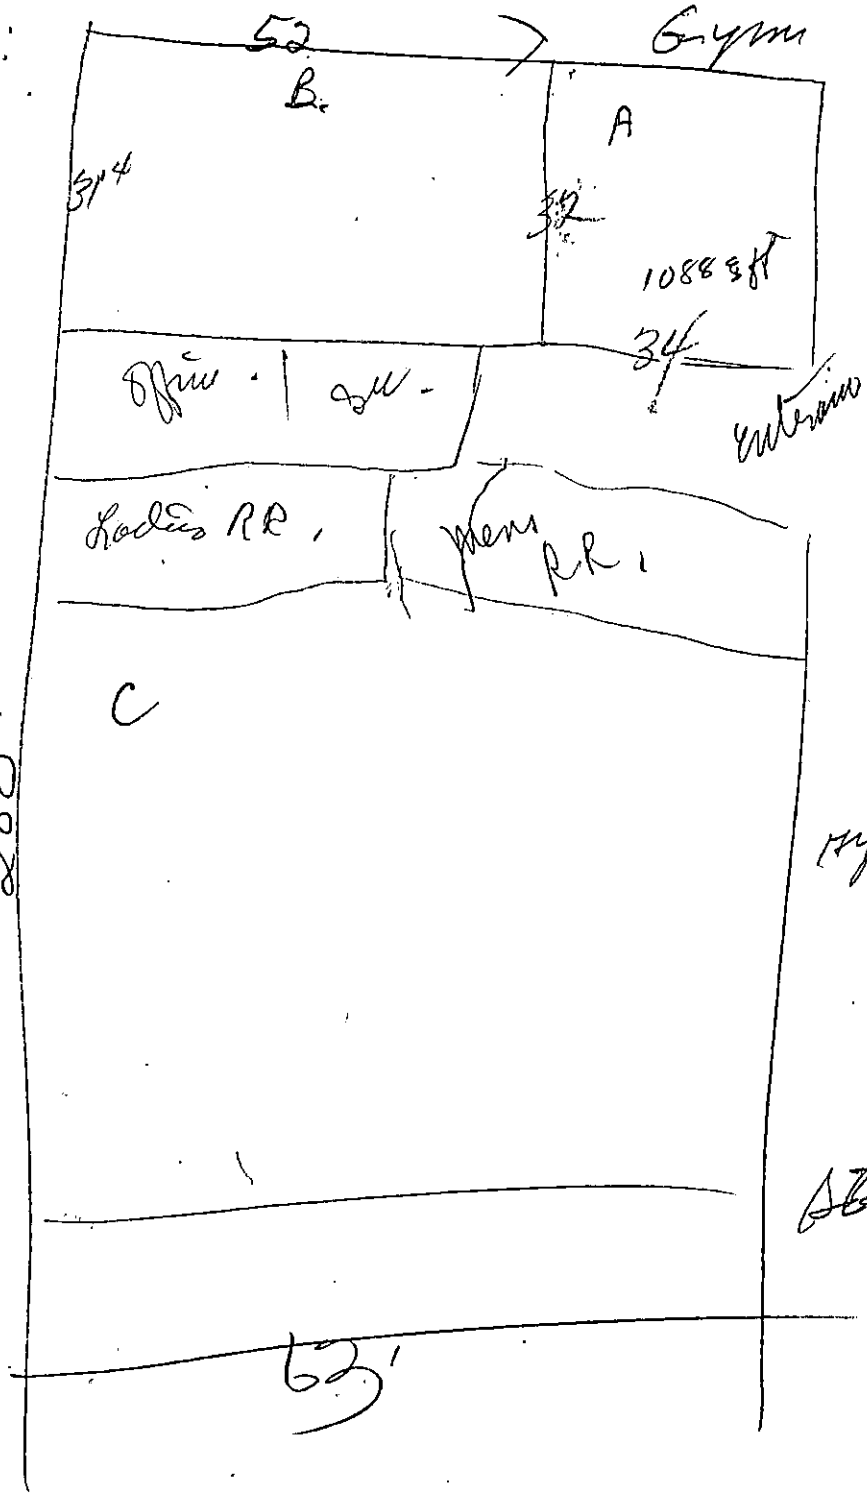
A. Ceiling 9'
textured material.
Walls. stone block
floor carpeted.
lights fastened
1088 sqft.

B. Foyer.
1512 sqft.

R.R. Wall Tile.
floor tile.
Ceiling textured
sheet Rock

Gym. walls stone Block
ceiling between Beams
textured sheetrock.
floor Hardwood

Storage. walls stone Block
outside
