AHERA THREE YEAR REINSPECTION

**Bakersfield Adventist Academy
Bakersfield, CA**

May 15, 2014

Central California Conference of 7th Day Adventists Bakersfield Adventist Academy

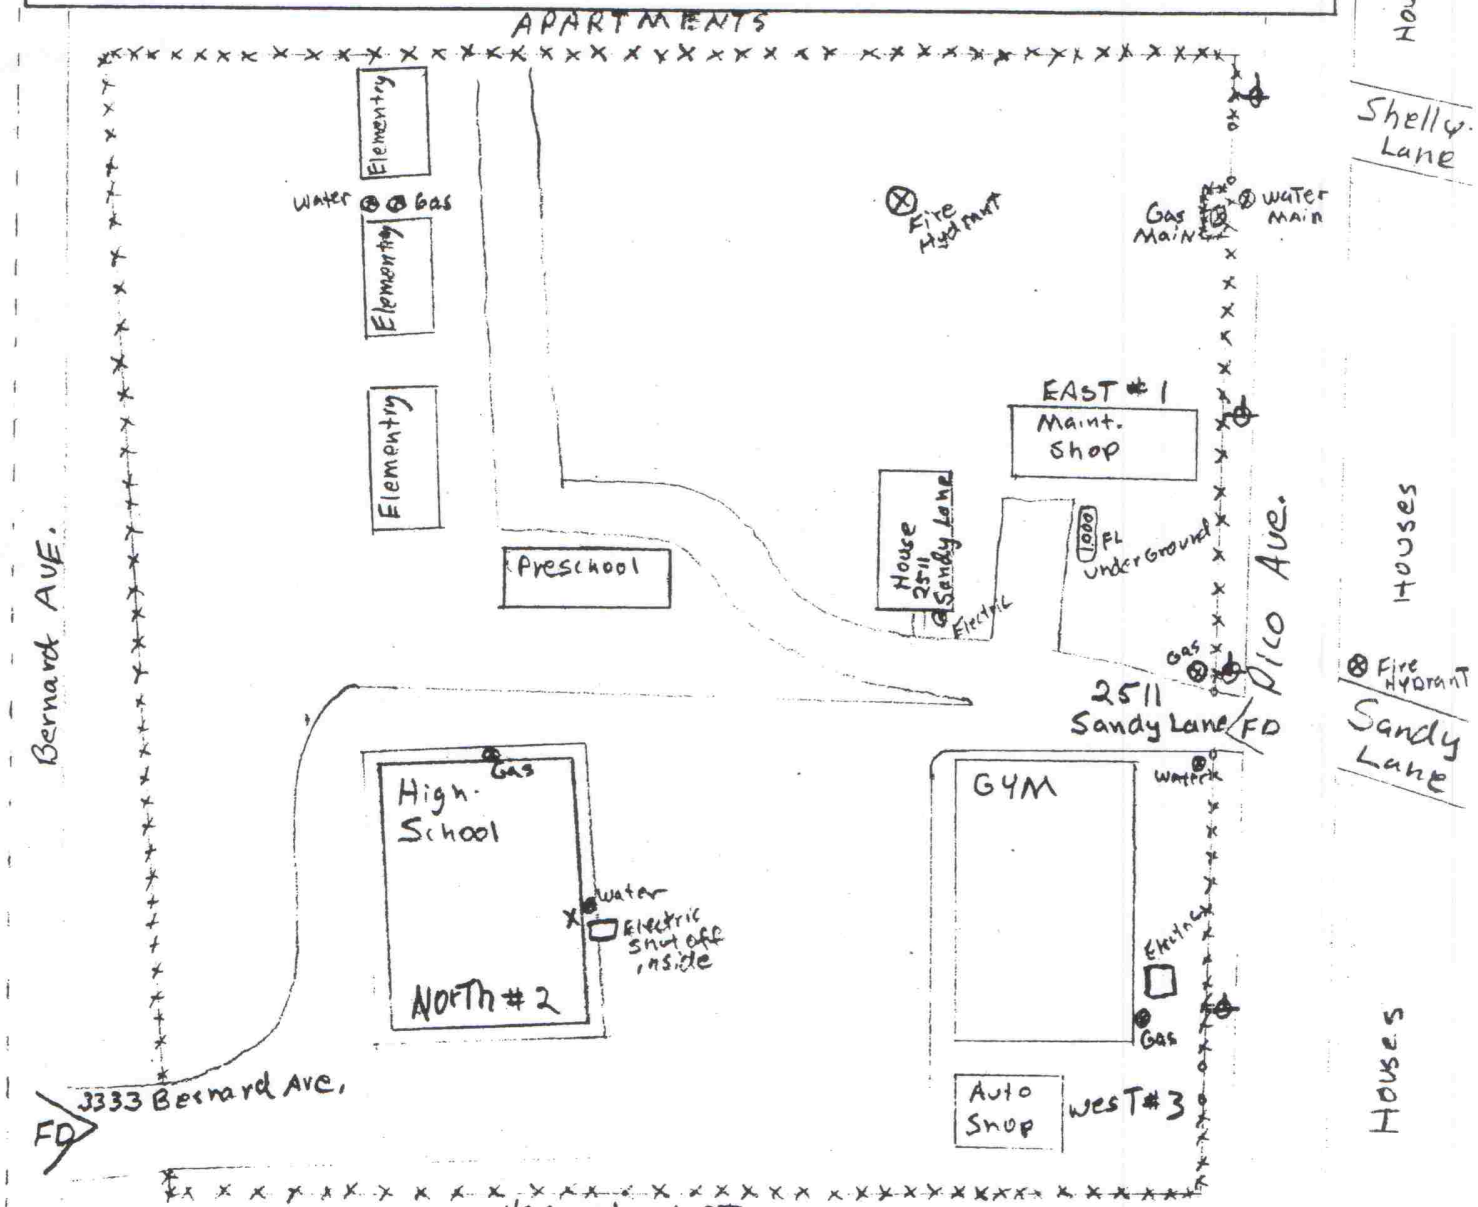
SITE/FACILITY DIAGRAM FORM 5

NORTH ←	SCALE:	BUSINESS NAME: <u>Bakersfield Adventist Academy</u>	FLOOR: OF
DATE: <u>9/8/87</u>		FACILITY NAME:	UNIT #: OF
(CHECK ONE) SITE DIAGRAM <input checked="" type="checkbox"/> FACILITY DIAGRAM <input type="checkbox"/>

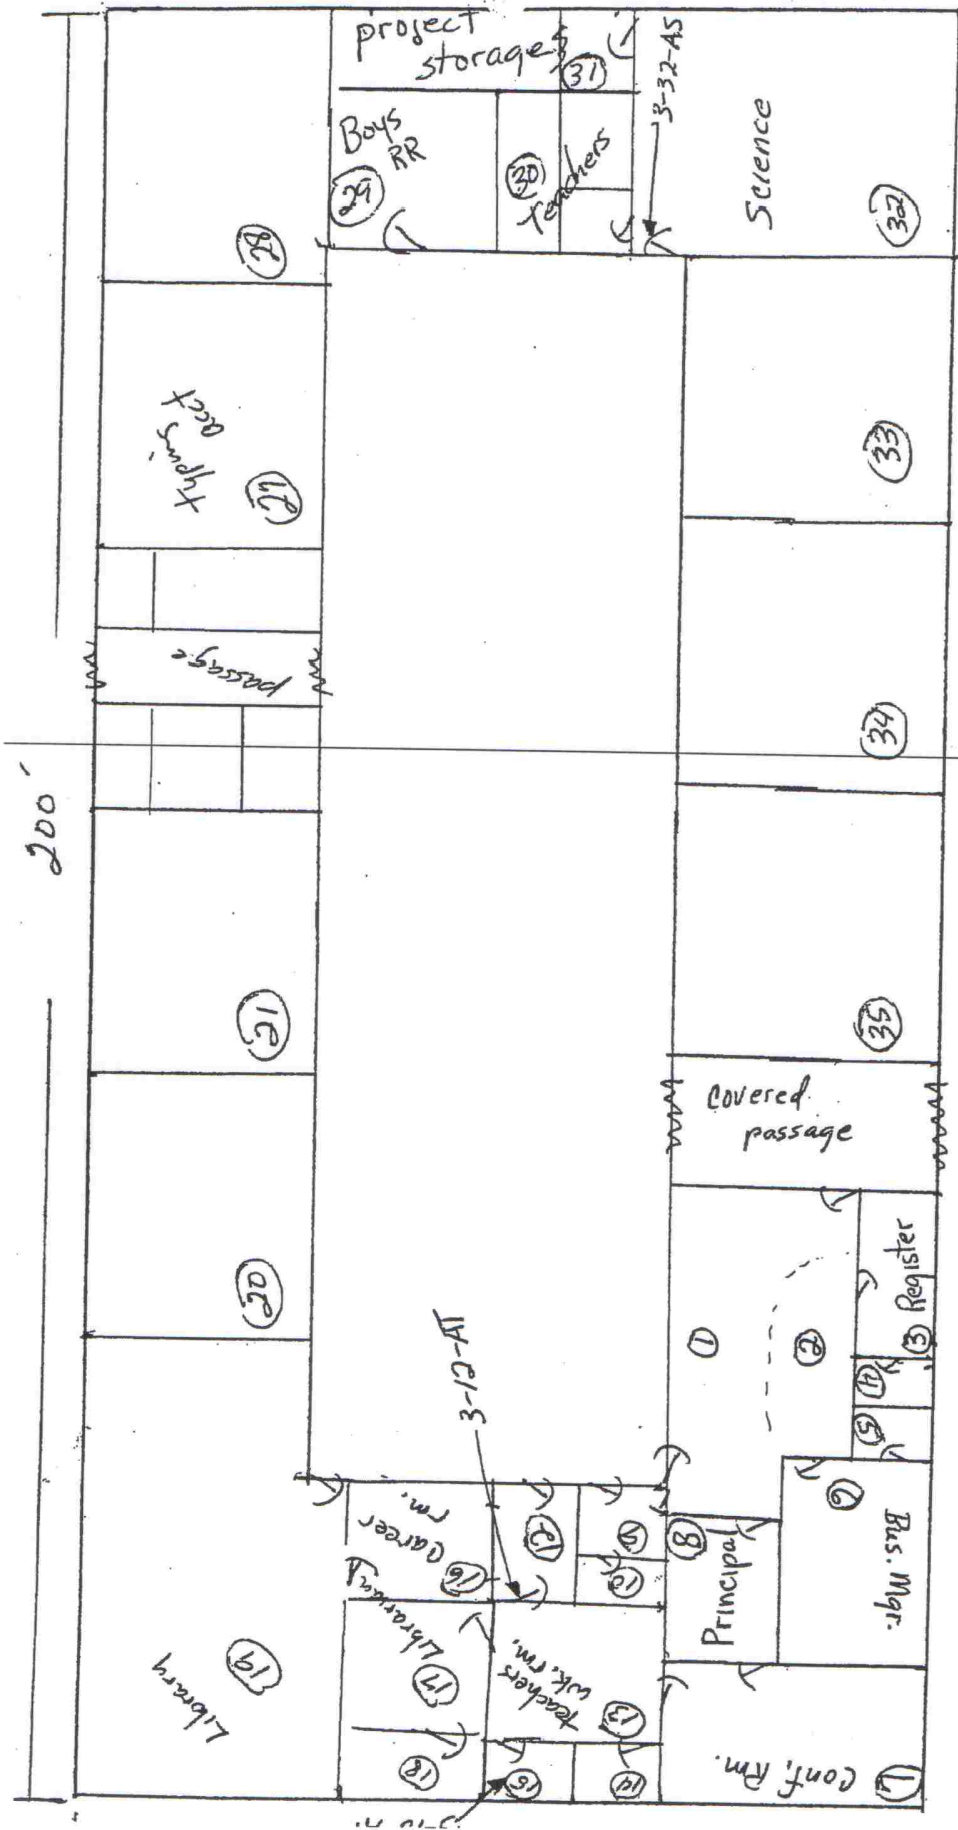
BAKERSFIELD SDA SCHOOL 9-12 GR. ACADEMY
CLASSROOMS AND ADMINISTRATIVE BLDG.

Sgt - 13,972

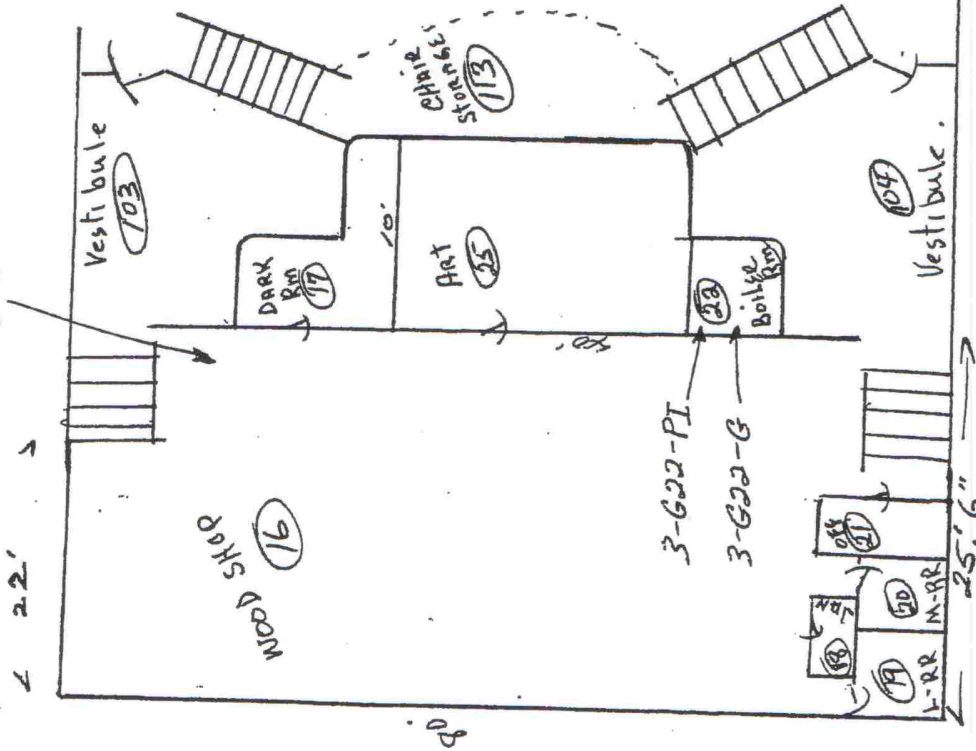
BAKERSFIELD GYM LOWER
2448 sq ft.

STAGE AREA.

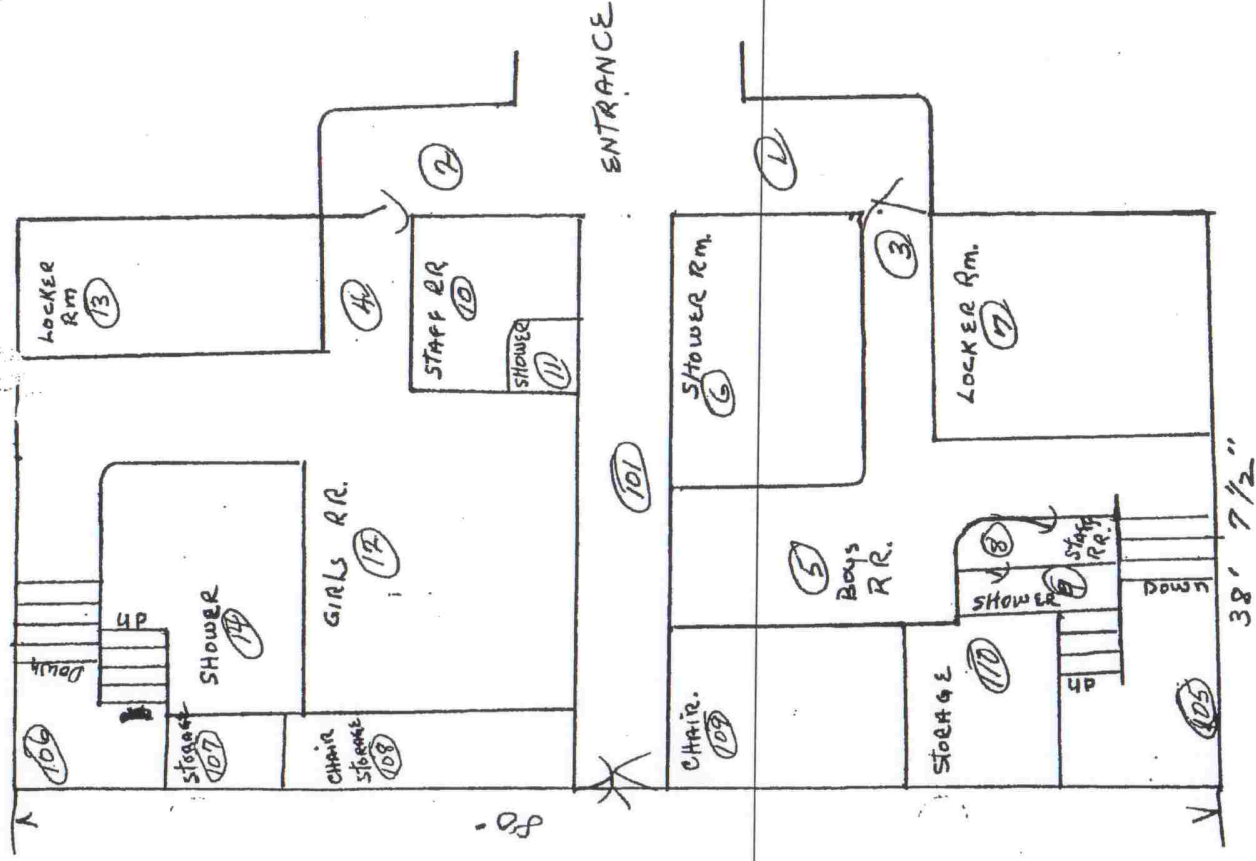
BAKERSFIELD SDA SCHOOL GYM LOWER AREA.
 UNDER HOME EC. Rms.
 3104 sq ft.

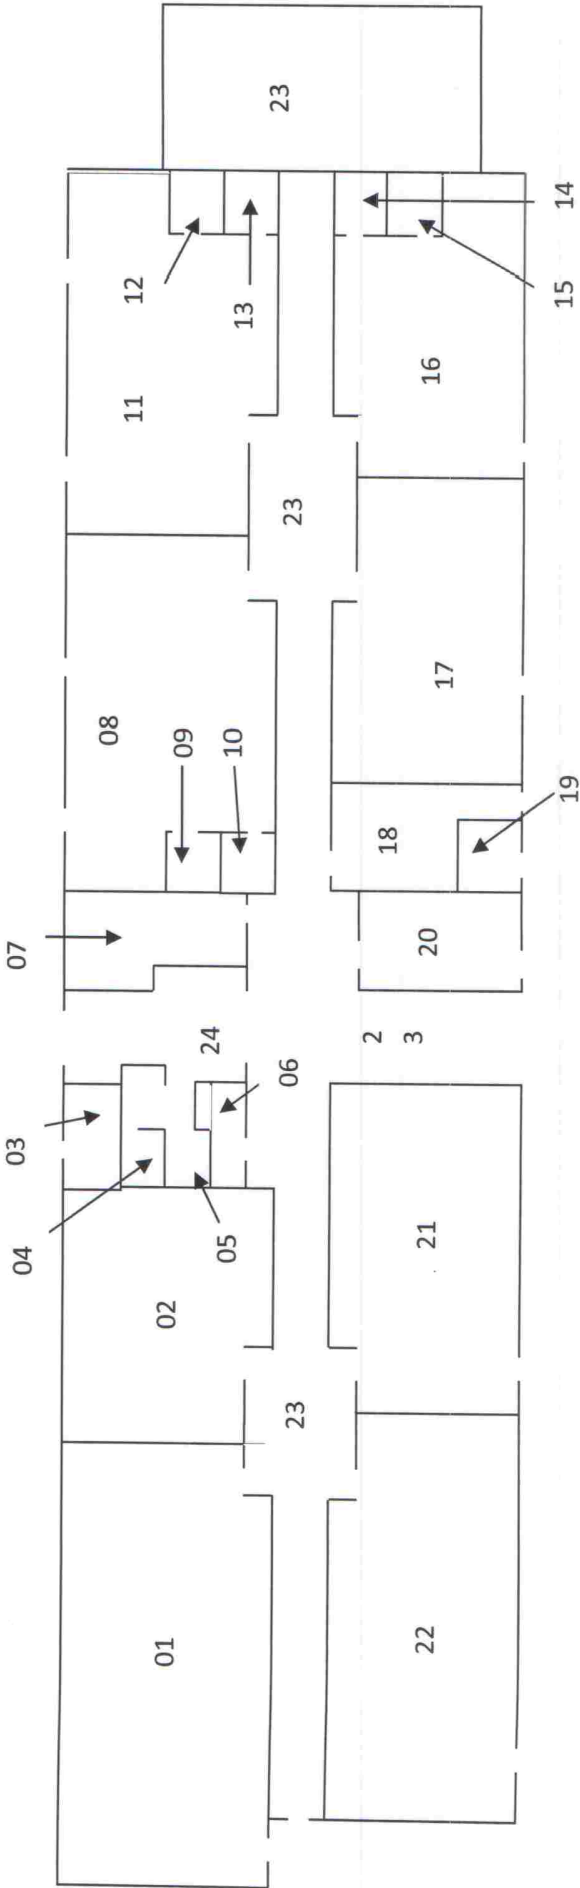
01 – Classroom (7 th & 8 th Grade)	10 - CR (Learning Center) Women's RR	19- Exterior Custodial
02 – Library	11 – Classroom (Kindergarten)	20-Boys RR
03 – Exterior Utility Room	12- Classroom K Boys RR	21-Classroom (5 th & 6 th Grade)
04 - Teacher Work room Women's RR	13- Classroom K Girls RR	22-Music
05 - Teacher Work Room Men's RR	14- Classroom 1/2 Boys RR	23 - Hallway
06-Custodial	15 - Classroom 1/2 Girls RR	24 – Teacher Work Room
07-Home and School Work Room	16- Classroom (1 st & 2 nd Grade)	
08- Classroom (Learning Center)	17-Classroom (3 rd & 4 th Grade)	
09 – CR (Learning Center Men's RR)	18 – Girls RR
