AHERA THREE YEAR REINSPECTION

**Fresno Adventist Academy
Fresno, CA**

March 28, 2014

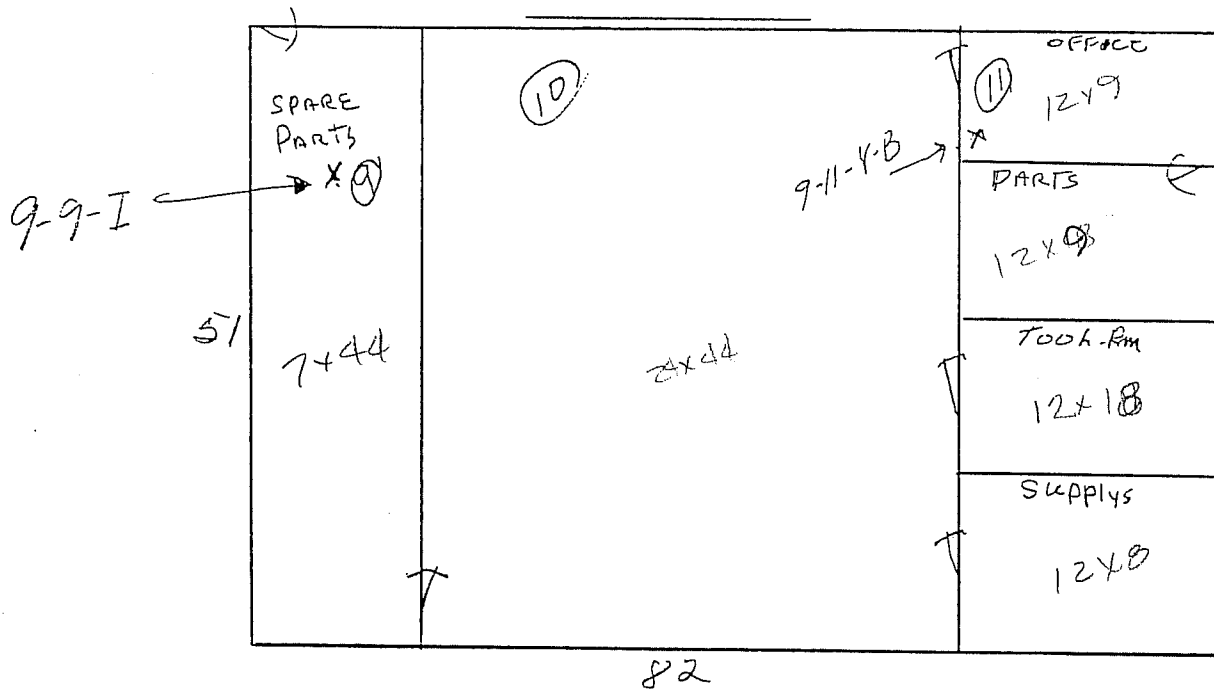
① BUS MAINTENANCE SHOP.
4182 sq ft.
 FRESNO SDA. ACADEMY
 No. 9

1 (C) QUONSET (WEST)
