AHERA THREE YEAR REINSPECTION

**San Francisco Adventist School
San Francisco, CA**

June 25, 2014

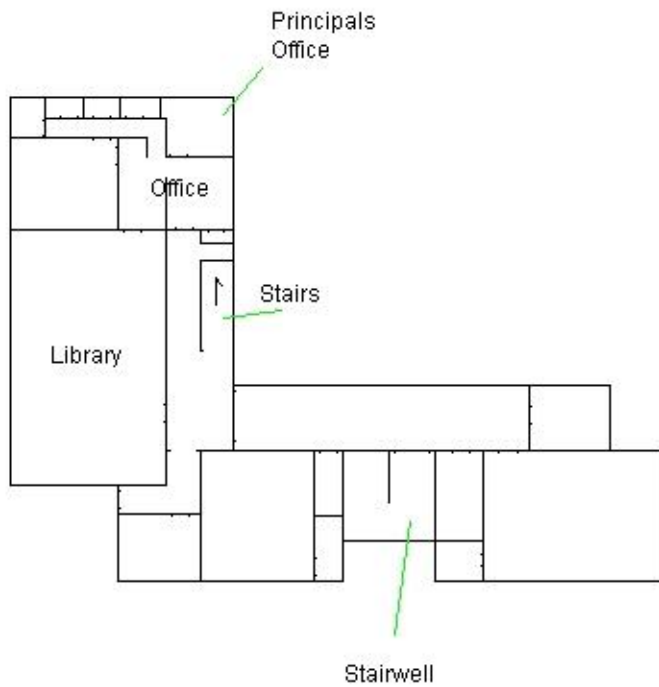
San Francisco, Seventh Day Adventist School
Main Building, second floor map
House: Main room (2nd floor)
