HAZARD MANAGEMENT SERVICES, INC.

Central California Conference of 7th Day Adventists

Sierra View Junior Academy

February 14, 2014

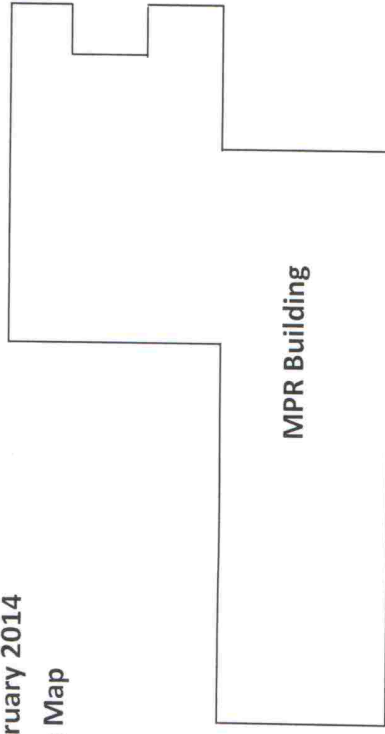
February 2014
Site Map

Central California Conference of Seventh-Day Adventists
Sierra View Junior Academy
F14017

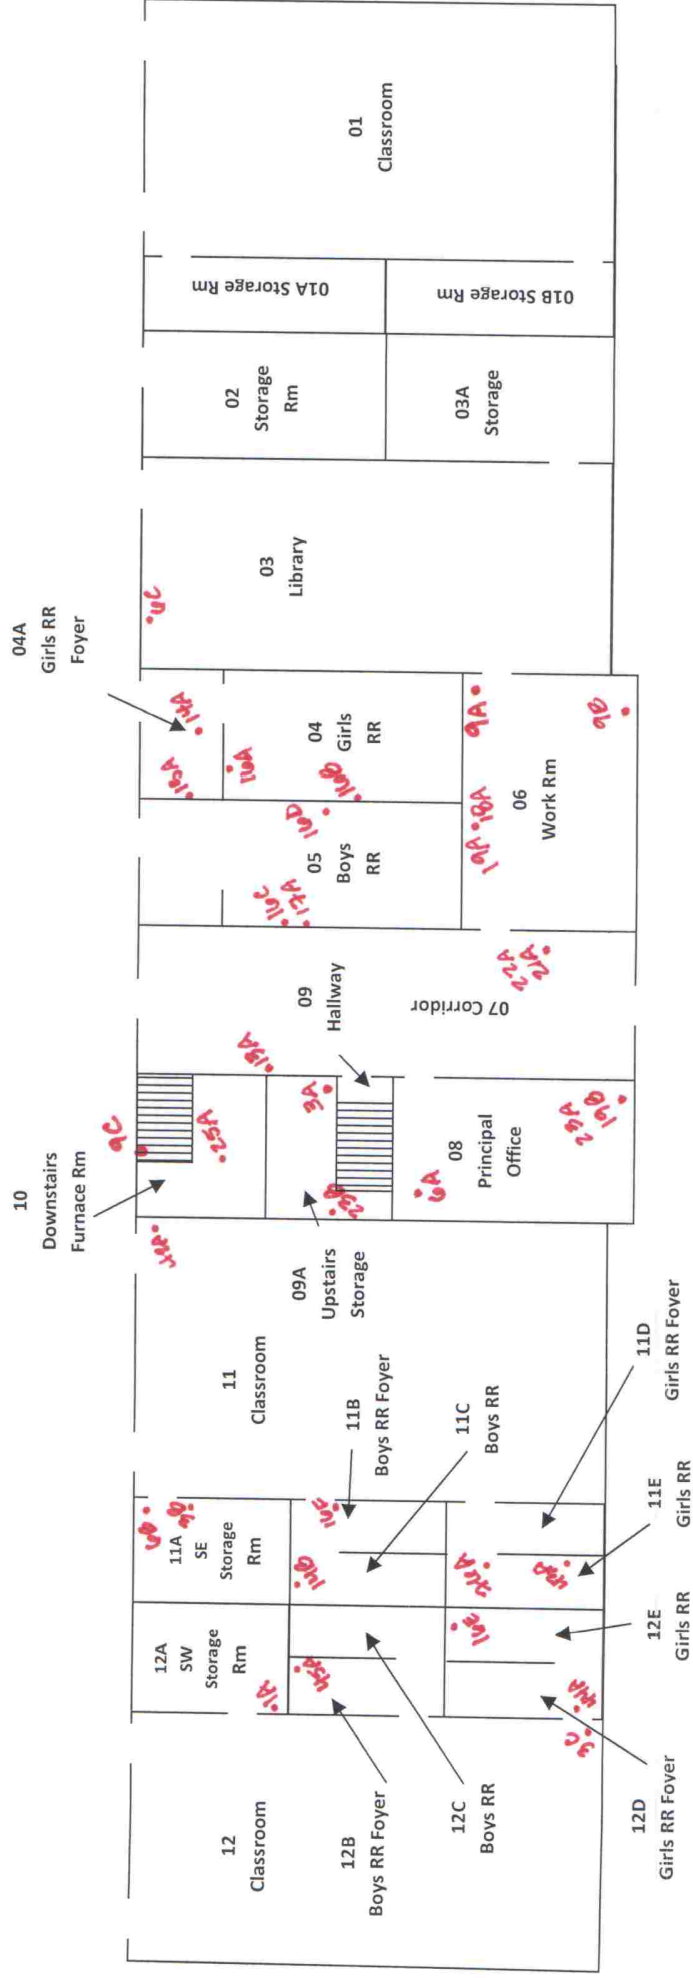
Sample Map

• = sample location & sample #

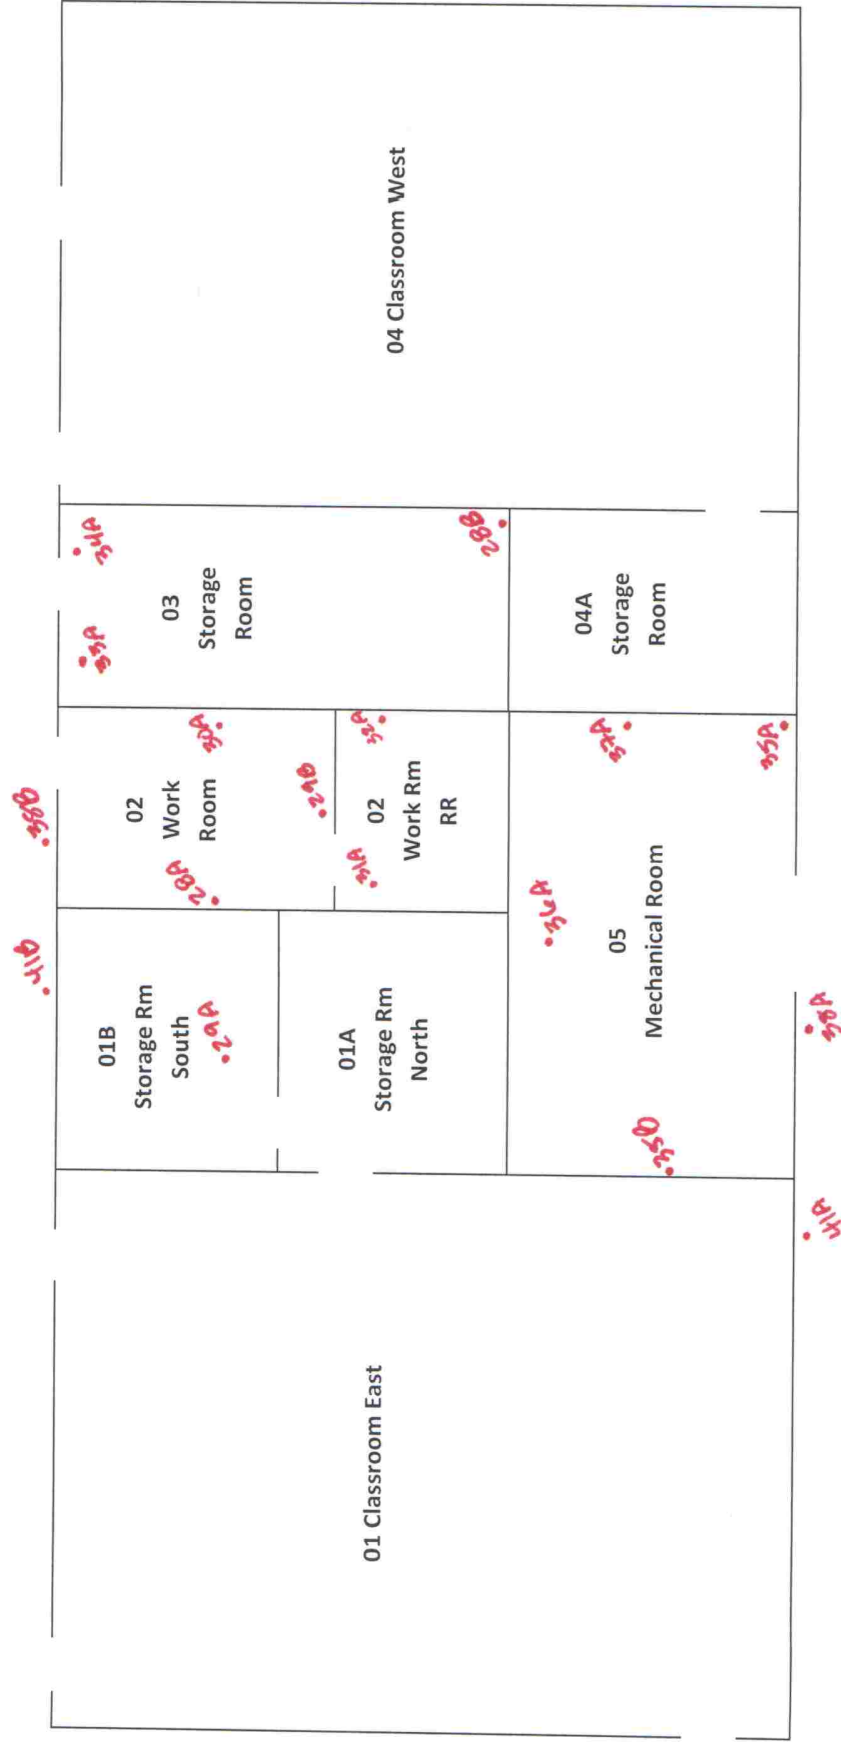
Sample Map

• = sample location & sample #

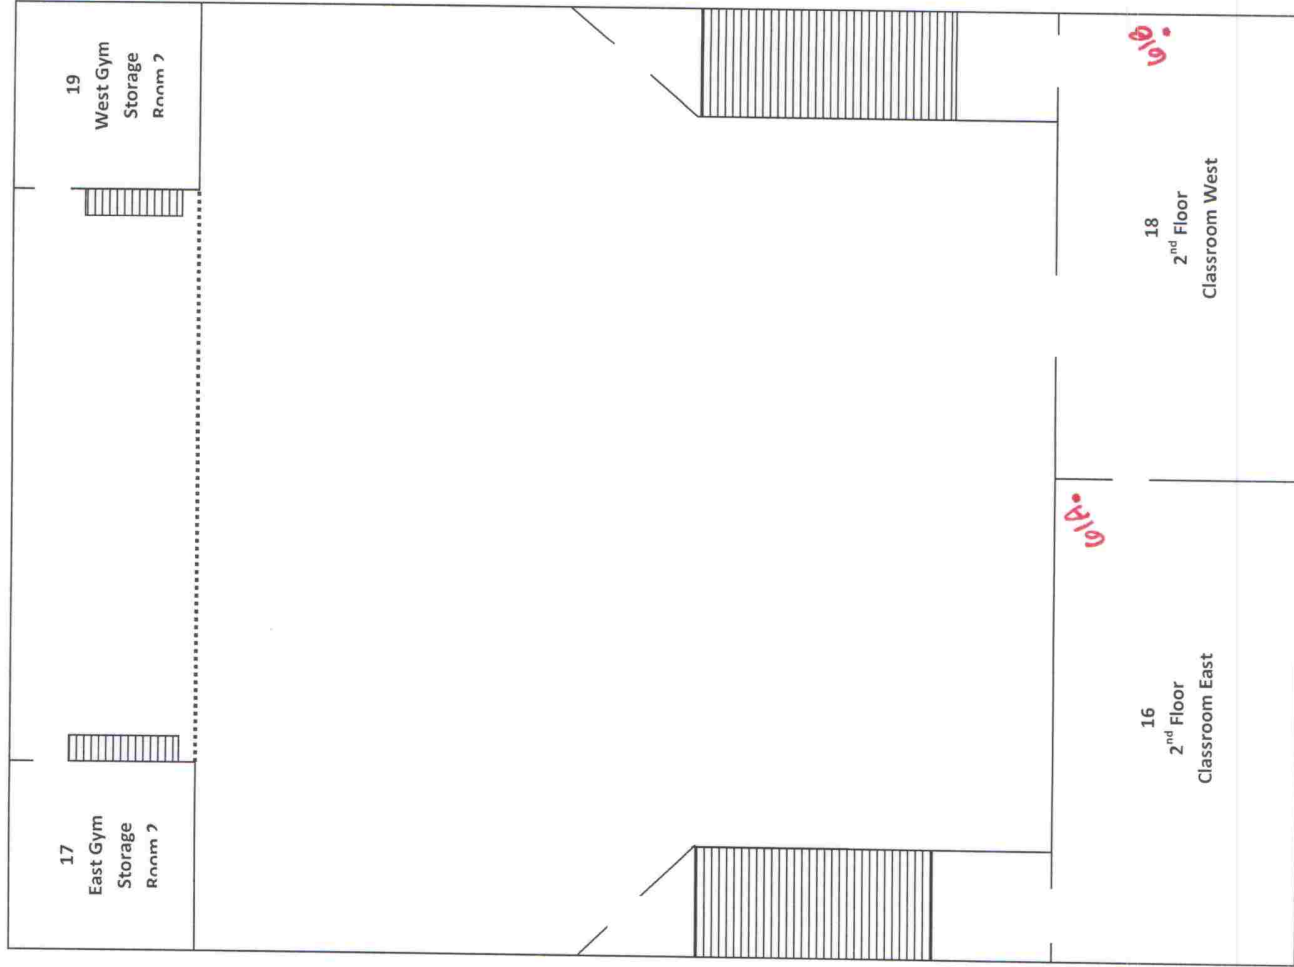
Central California Conference of Seventh-
Day Adventists
Sierra View Junior Academy
F14017
February 2014
Gymnasium Building 2nd Floor

Sample Map
● = sample location + sample #

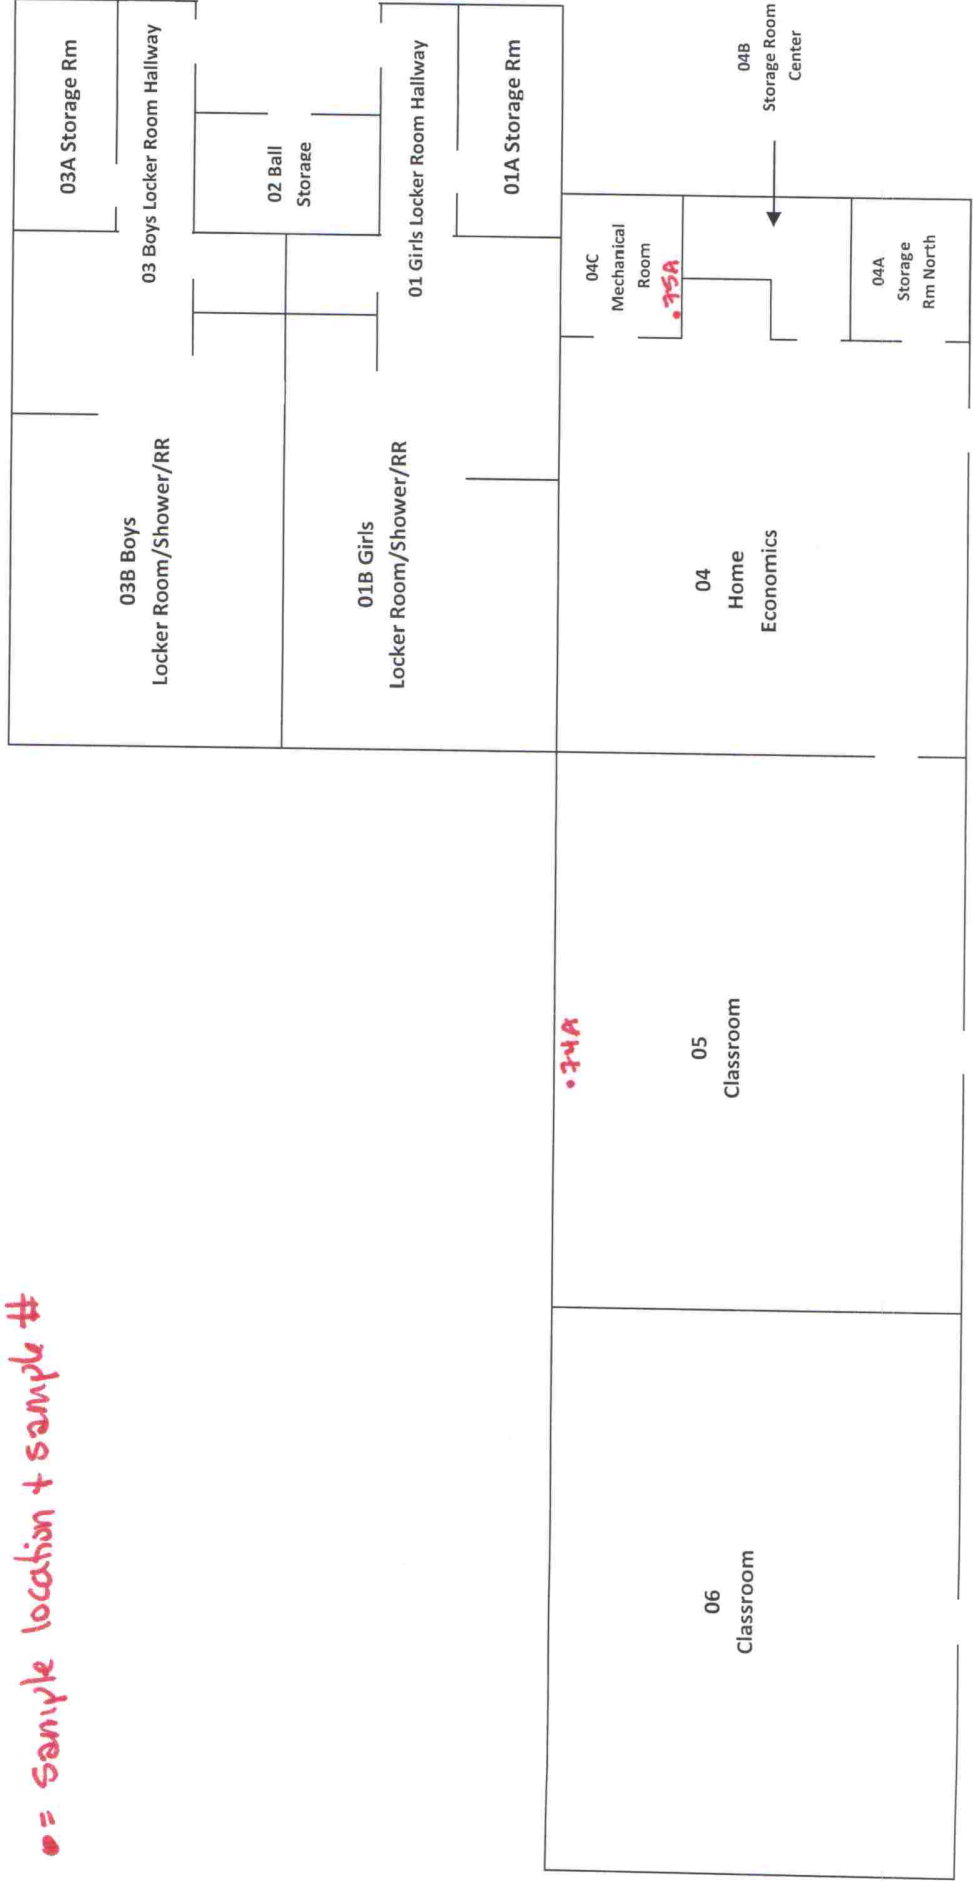
Central California Conference of Seventh-
Day Adventists
Sierra View Junior Academy
F14017
February 2014
Multi-Purpose Building

Sample Map

● = sample location + sample #
