## **AHERA THREE YEAR REINSPECTION**

**Valley View Junior Academy  
Arroyo Grande, CA**

**August 26, 2014**

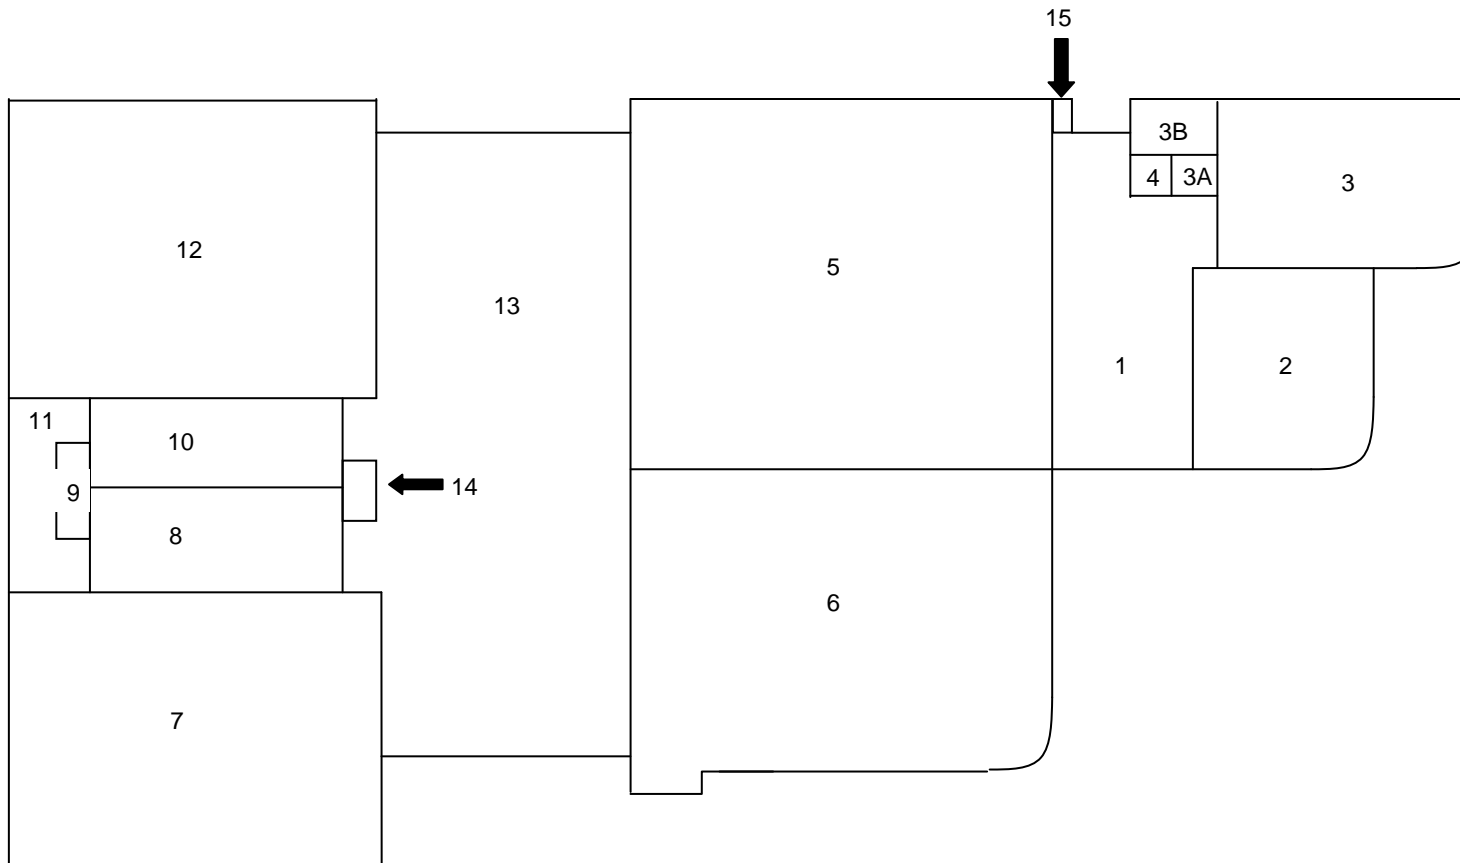
Administration Building

- 1 – Main Entry
- 2- Office
- 3 – Staff Lounge
- 3A – Storage
- 3B – Staff Lounge
- 4 – Custodial Closet
- 5 – Classroom
- 6 – Classroom
- 7 – Classroom
- 8 – Men's RR
- 9 – Mechanical Room
- 10 – Women's RR
- 11 – Classroom Hallway
- 12 - Classroom
- 13 – Corridor
- 14 – Custodial Closet
- 15 – Exterior Closet

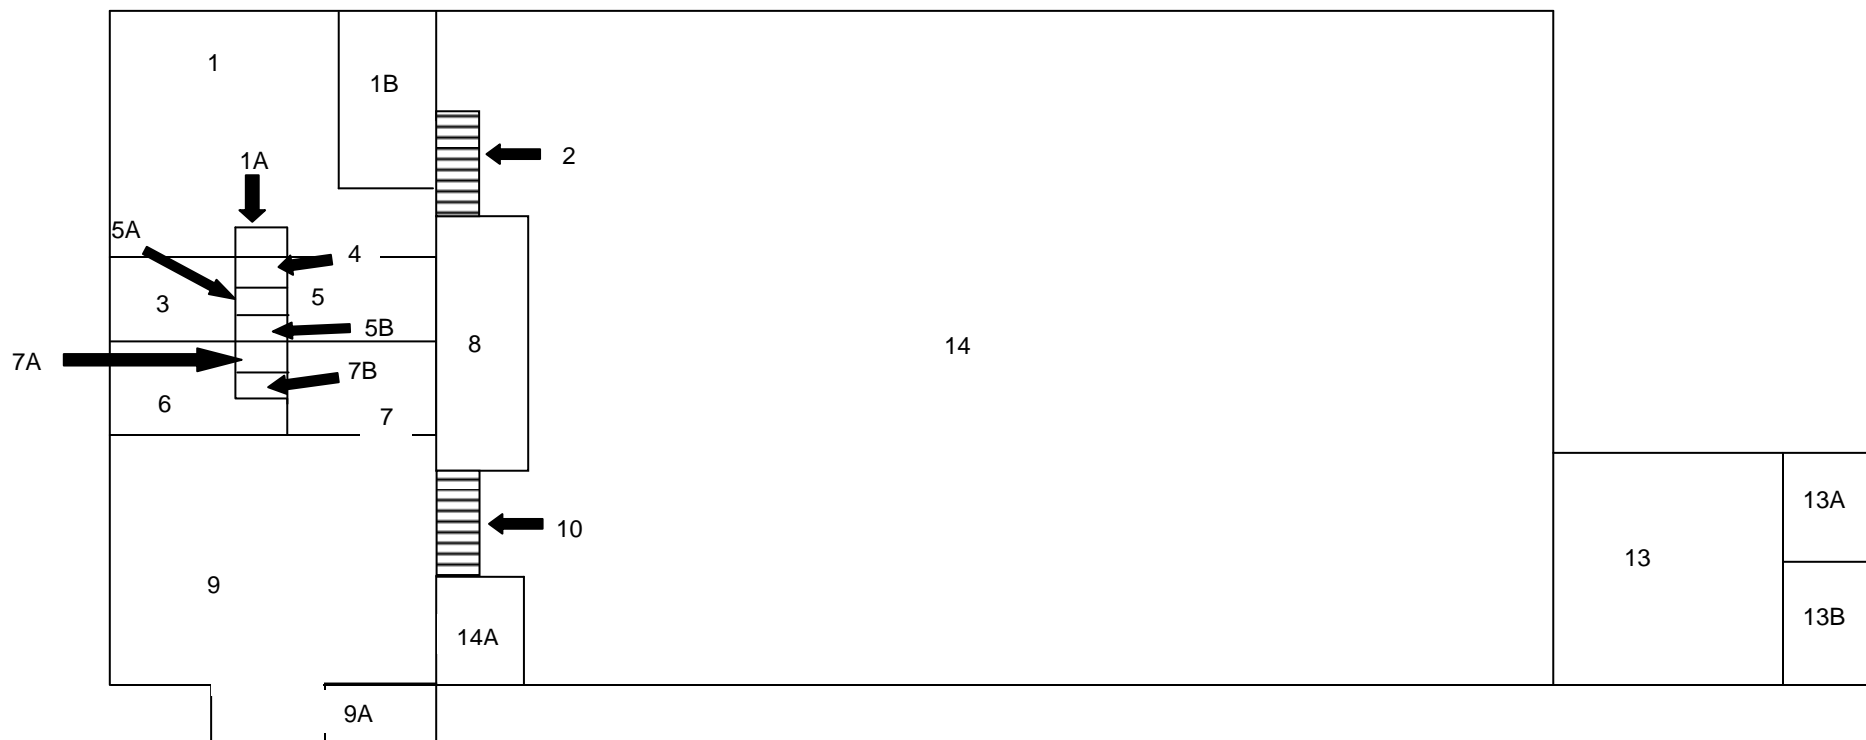
1 – Home Ec	7 – Boys’ L/R
1A – Custodial Closet	7A – North Storage
01B – Dry Storage	7B – South Storage
2- NW Stairwell	8 – Equipment Storage
3 – Women’s RR	9 - Library
4 – Girls’ L/R Hall	9A - Storage
5 – Girls’ L/R	10 – SW Stairwell
5A – North Storage	13 - Classroom
5B – South Storage	13A - Storage
6 – Men’s RR	13B – Office
14 – GYM	14A – SW Stage Storage

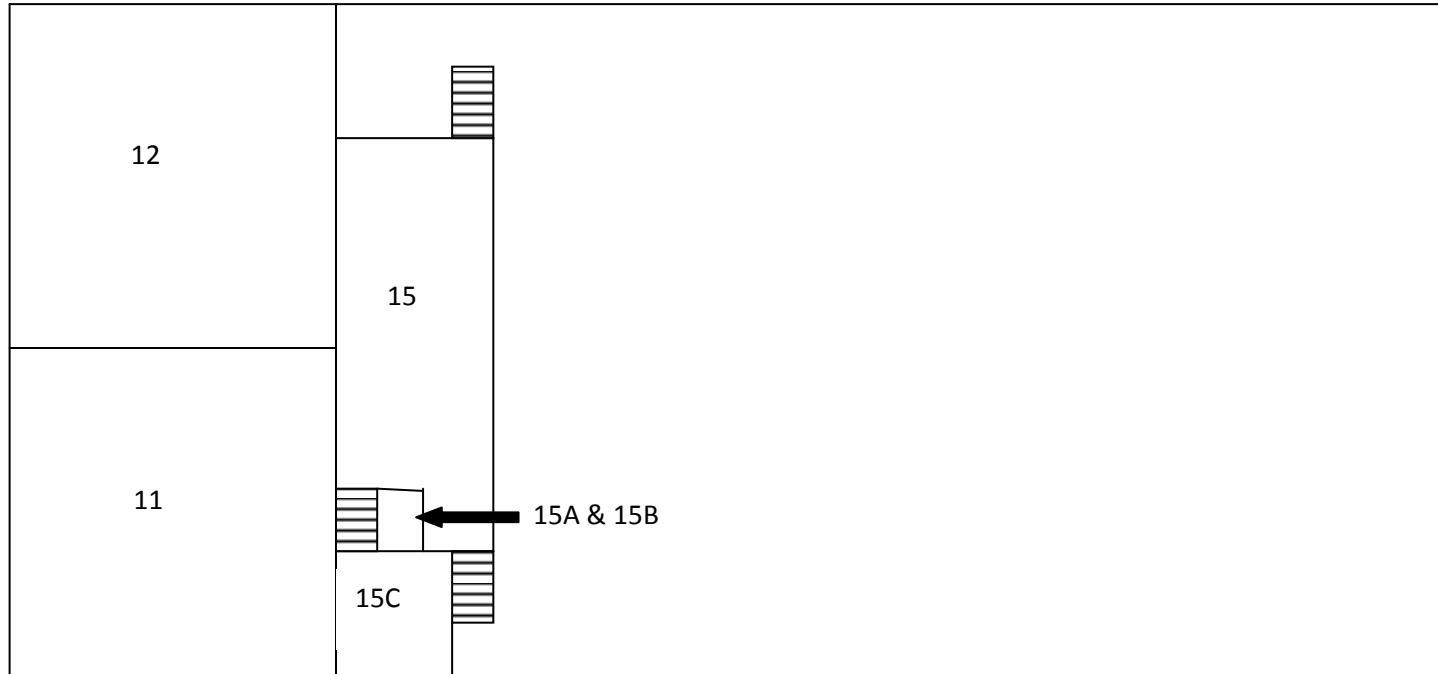
- 11 – Classroom South
- 12 - Classroom North
- 15 – Stage
- 15A – SW Stage Level Storage
- 15B – Prop Closet
- 15C – Stage Storage
