AHERA THREE YEAR REINSPECTION

**Central California Conference of
Seventh-Day Adventists
Central Valley Christian Academy
Ceres, CA**

October 21, 2014

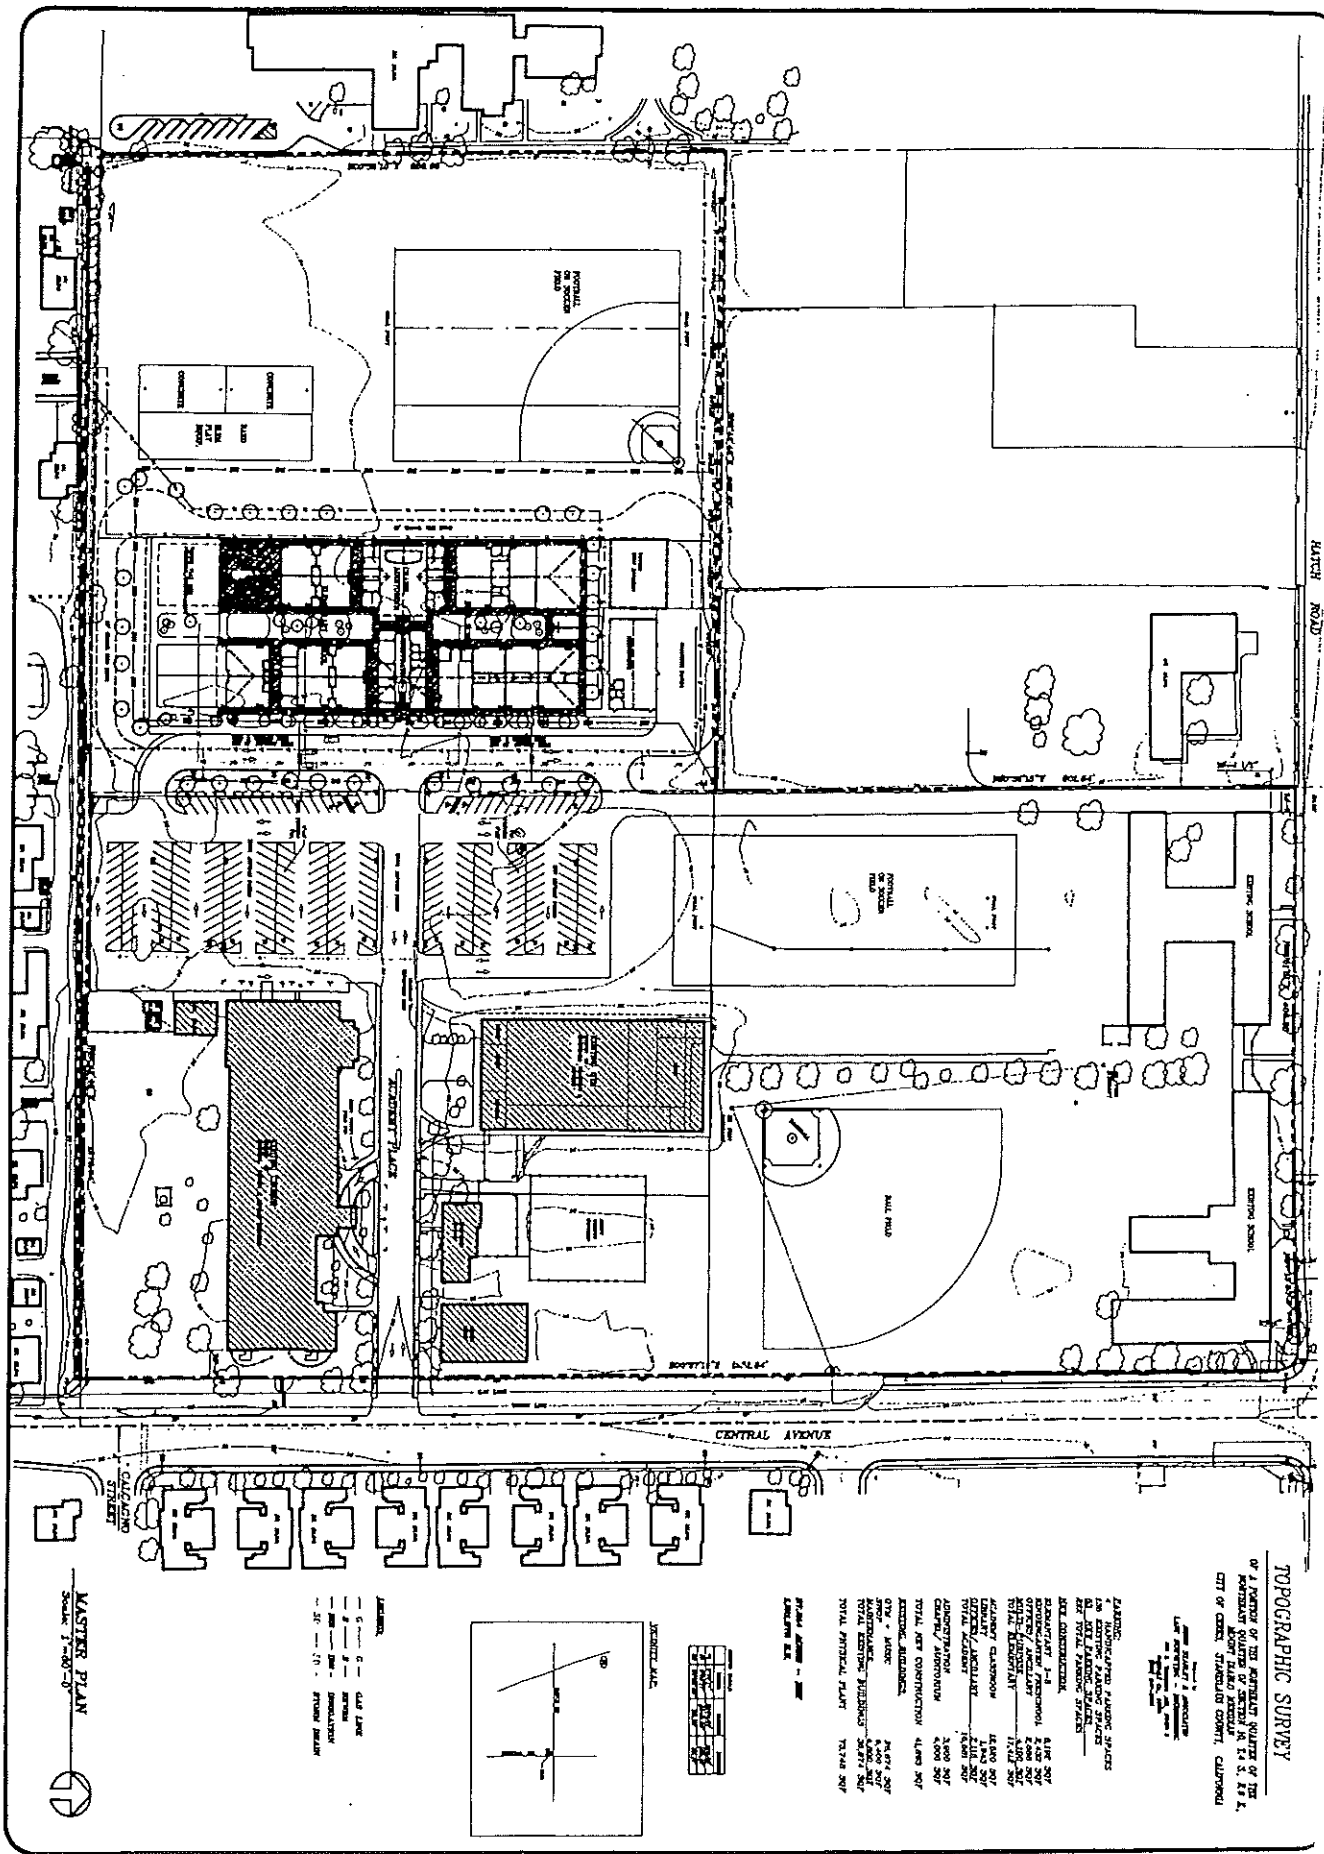
A0.01

TOPOGRAPHIC SURVEY

OF A PORTION OF THE ADVENTIST QUARTER OF THE
NORTHWEST QUARTER OF SECTION 16, T4 S, R4 E, S.
CITY OF CROWN, STANBOL COUNTY, CALIFORNIA
